Project No./Contract No.	Project Title / Location	Day of Report	Report No.
6389	BRC Eastside Common Areas Soils Remediation	22-Jan-10	549

DAILY PRODUCTION & QUALITY CONTROL REPORT

DAILY PHOTO LOG

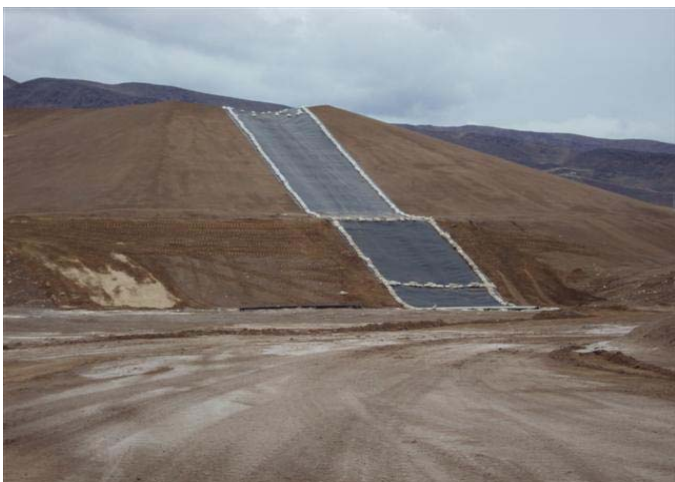
Photo 1

CAMU: Phase IIIB, North slope, placed for temporary storm run off.

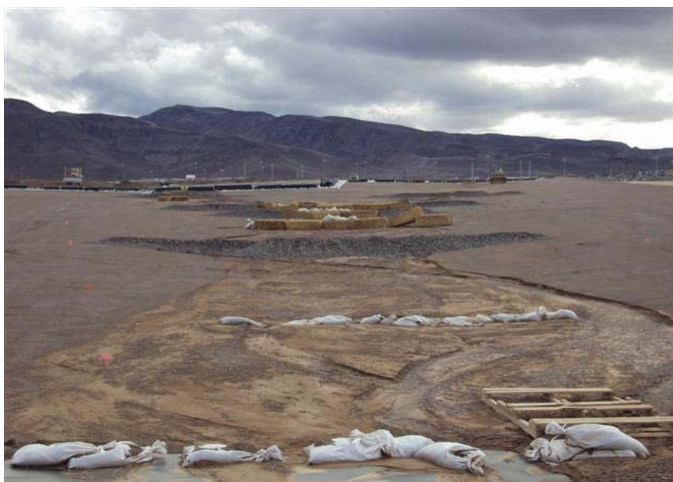
Photo 2

CAMU: Phase I and Phase II, temporary check dams.

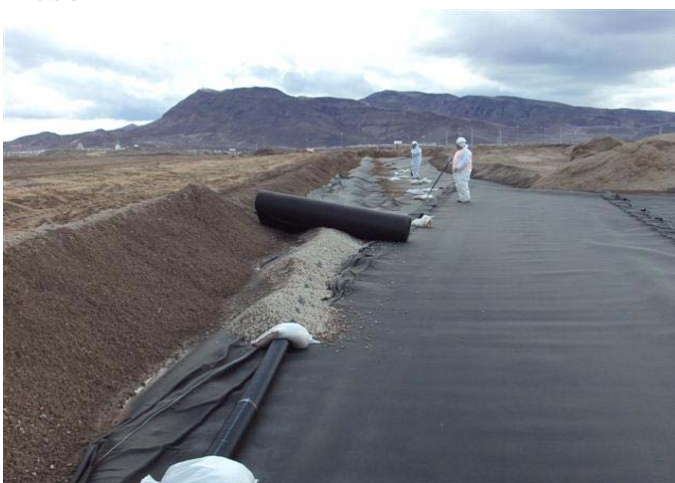
Photo 3

CAMU: Phase I and Phase II, top, LCRS Pipe installation.

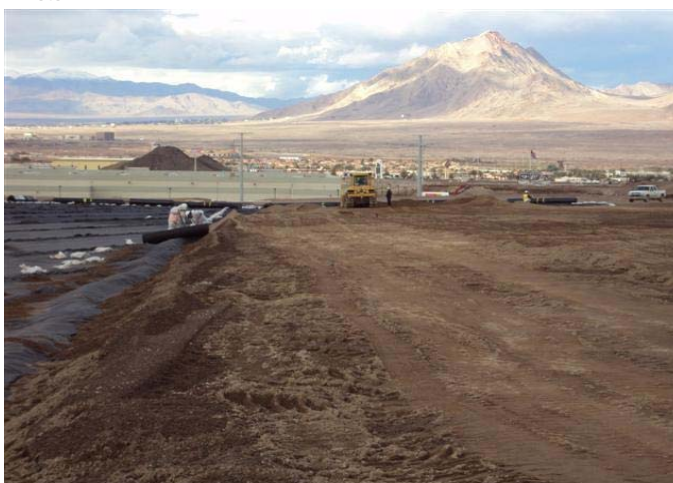
Photo 4

CAMU: Phase II and Phase I, LCRS pipe installation and final cover soils.
