DAILY PRODUCTION & QUALITY CONTROL REPORT

Project No./Contract No.	Project Title / Location	Day of Report	Report No.
6389	BRC Eastside Common Areas Soils Remediation	31-Jul-08	36

DAILY PHOTO LOG

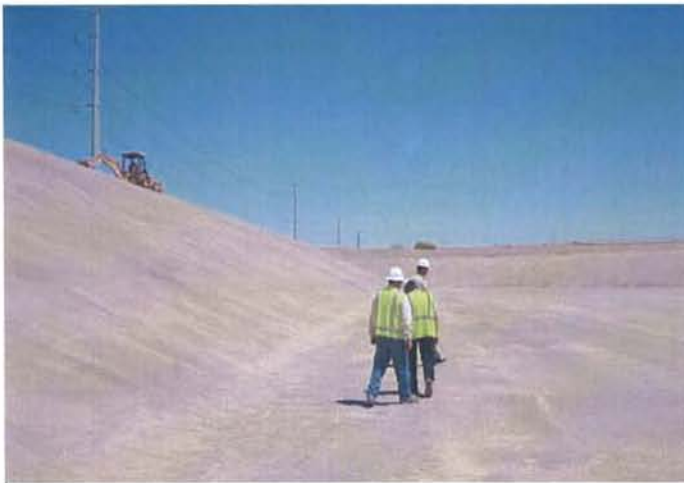
Photo 1

Inspected Phase 1 subgrade, floor and west slope with Ron Perry, ASW, state inspector, Approved.
Inspected 12" capped haul roads for degradation. All areas ok.

CAMU: Ron Perry, ASW, State Liner Inspector, on site. Inspected subgrade of Phase 1. Approved.

CAMU, Phase 1, Subgrade Inspection.

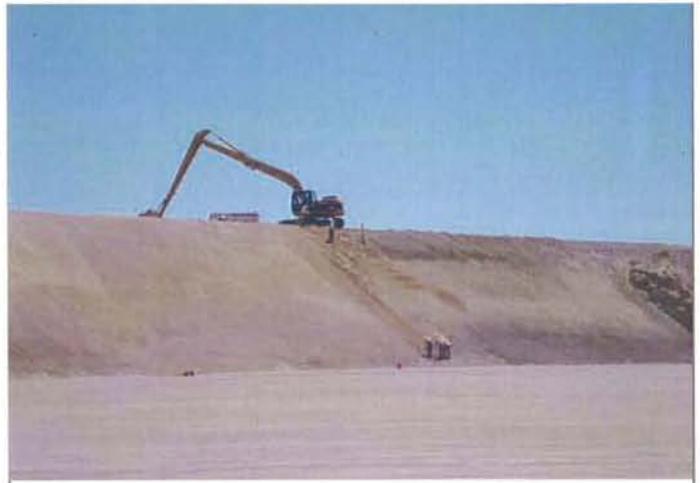
Photo 2

CAMU, Phase 1, East slope grading preparation for liner.

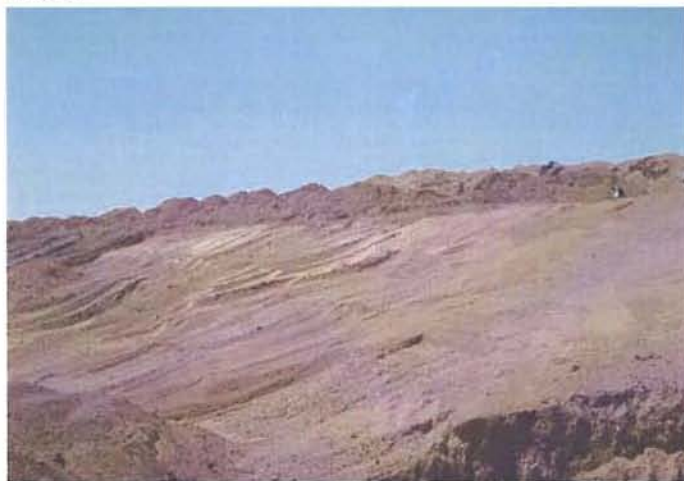
Photo 3

Eastside, SW-8, half of slope has been remediated. Half to follow.

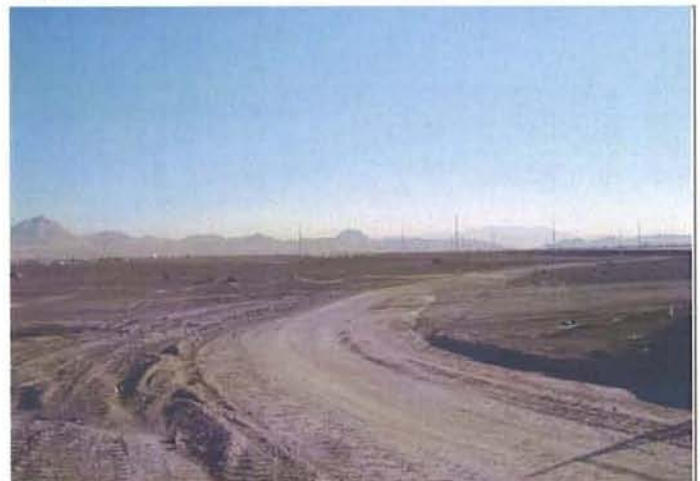
Photo 4

CAMU: Burrowing Owls area. Barracading moved out to 100' X 100'.

CAMU: East side, Burrowing Owls, Barracading moved out to 100' X 100'.
