DAILY PRODUCTION & QUALITY CONTROL REPORT

Project No./Contract No.	Project Title / Location	Day of Report	Report No.
6389	BRC Eastside Common Areas Soils Remediation	02-Aug-08	38

DAILY PHOTO LOG

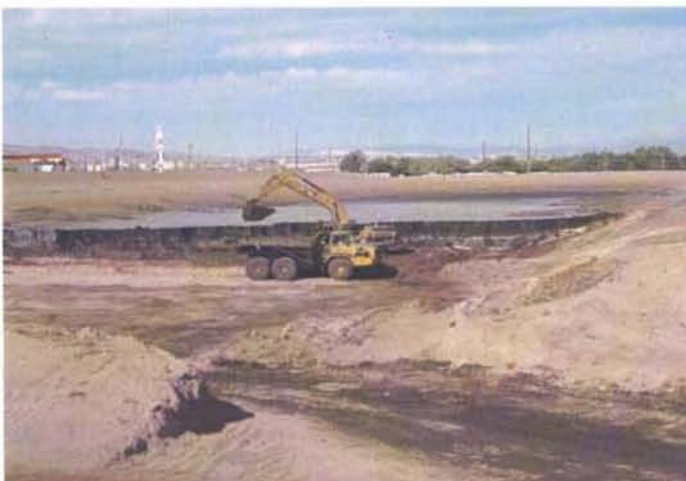
Photo 1

Eastside, SW-4 load out.

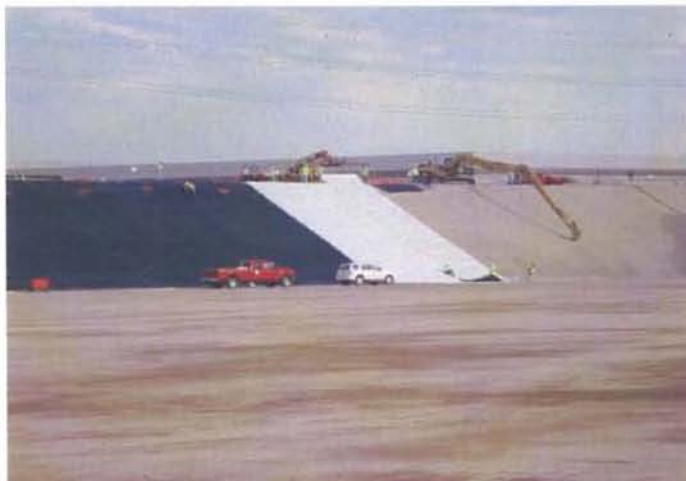
Photo 2

CAMU, Phase 1, Liner Crew Deploying liner on West Slope.

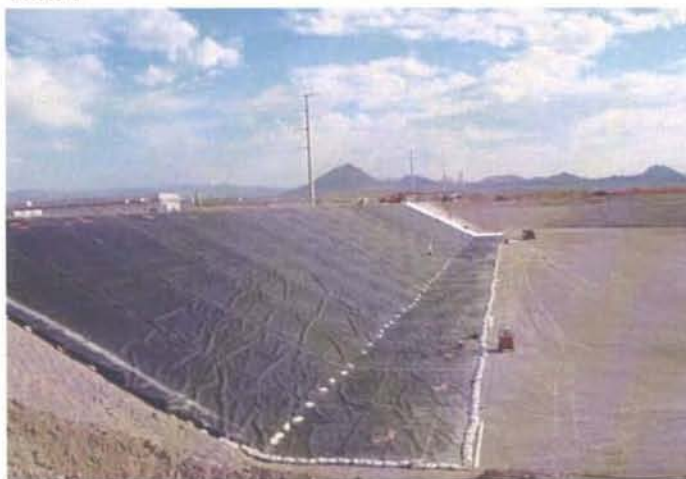
Photo 3

CAMU, Phase 1 Liner deployed Saturday, end of day..

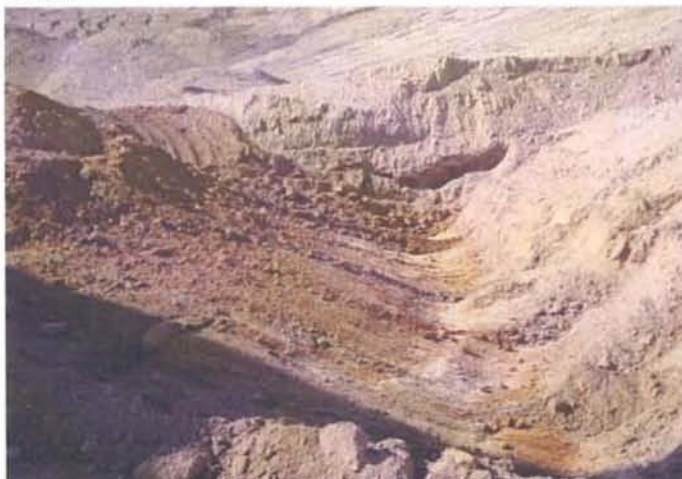
Photo 4

Eastside, SW-8 discolored soils excavated 5' below liner. Still showing discoloration.
