DAILY PRODUCTION & QUALITY CONTROL REPORT

Project No./Contract No.	Project Title / Location	Day of Report	Report No.
6389	BRC Eastside Common Areas Soils Remediation	15-Aug-08	49

DAILY PHOTO LOG

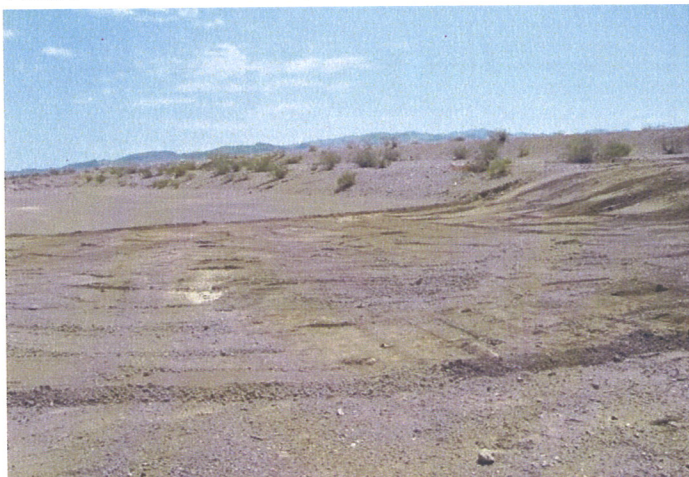
Photo 1

Eastside, Sewer Realignment Northern most scraping area.

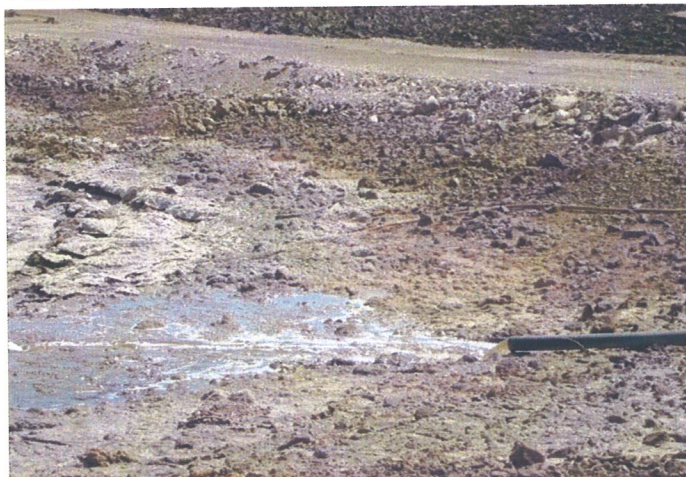
Photo 2

Eastside, Dewatering of SC-1 to SW-12.

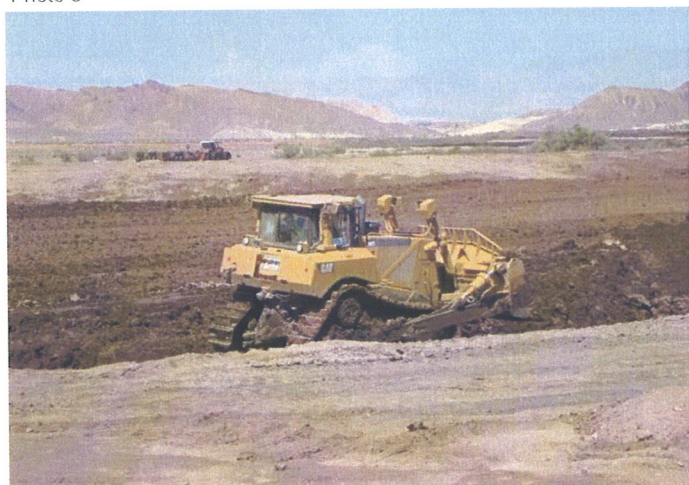
Photo 3

Eastside, SW-9. Being pushed up after drying process.

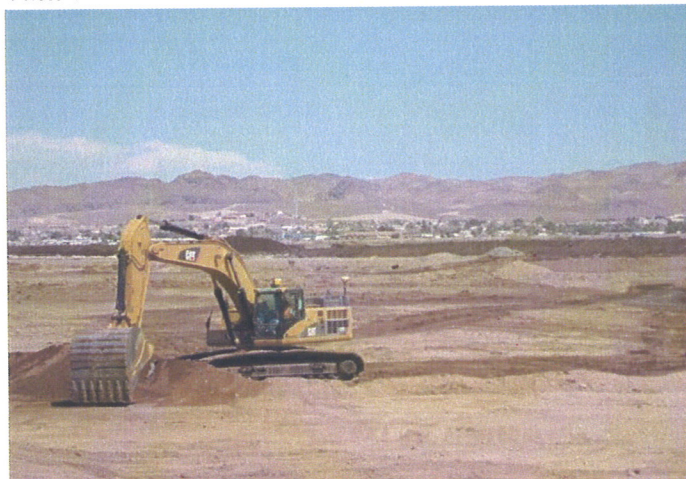
Photo 4

Eastside, SW-6, final scraping operation.
