## DAILY PRODUCTION & QUALITY CONTROL REPORT

Project No./Contract No.	Project Title / Location	Day of Report	Report No.
6389	BRC Eastside Common Areas Soils Remediation	29-Oct-08	115

### Eastside Mixing and Drying Activity:

### DAILY PHOTO LOG

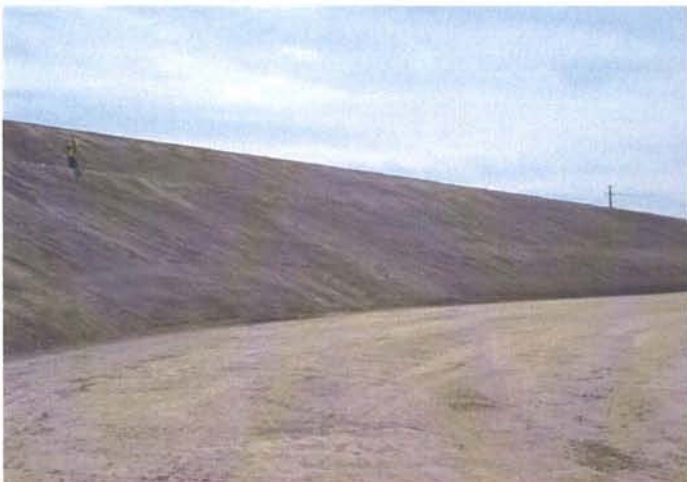
Photo 1

CAMU: Phase II, South slope prepared for subgrade inspection.

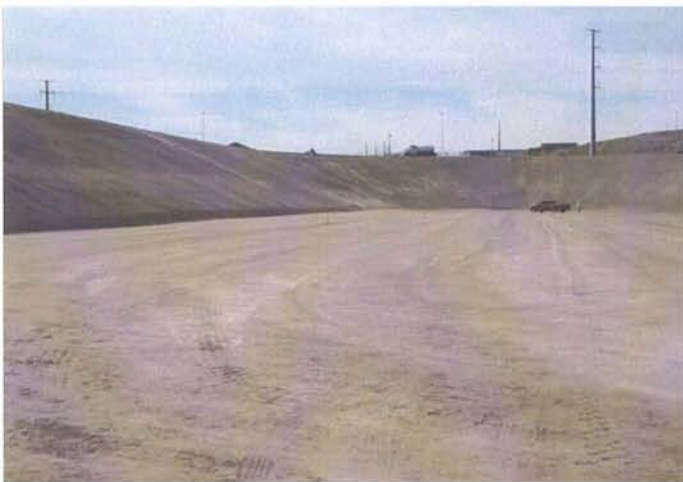
Photo 2

CAMU: Phase II South end floor prepared for subgrade inspection.

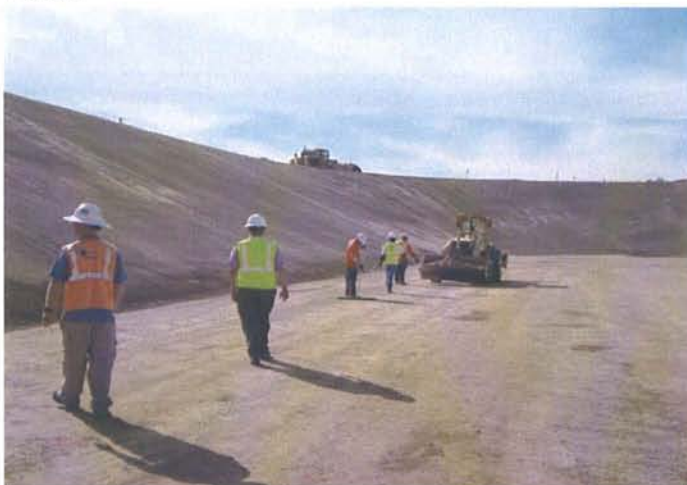
Photo 3

CAMU: Phase II subgrade inspection walk threw.

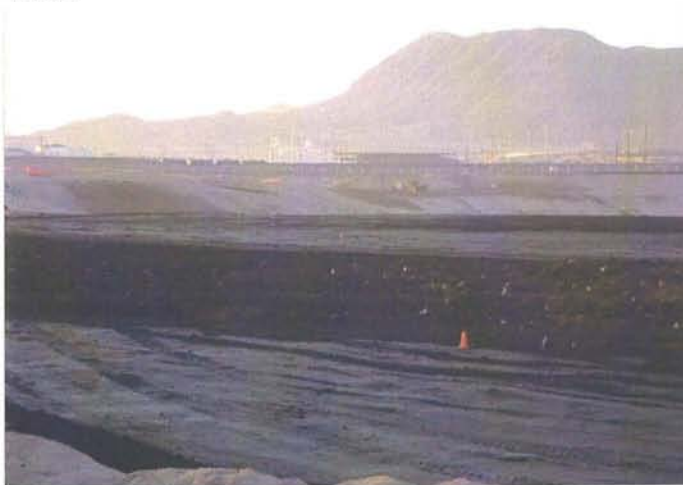
Photo 4

CAMU: Rejected lift in phase I being reworked.
