Project No./Contract No.	Project Title / Location	Day of Report	Report No.
6389	BRC Eastside Common Areas Soils Remediation	30-May-09	320

DAILY PRODUCTION & QUALITY CONTROL REPORT			
Project No./Contract No.	Project Title / Location	Day of Report	Report No.
6389	BRC Eastside Common Areas Soils Remediation	30-May-09	320
Description of Work Executed Today			
<b>Eastside Mixing and Drying Activity:</b>			
<b>Day Shift:</b>

#### DAILY PHOTO LOG

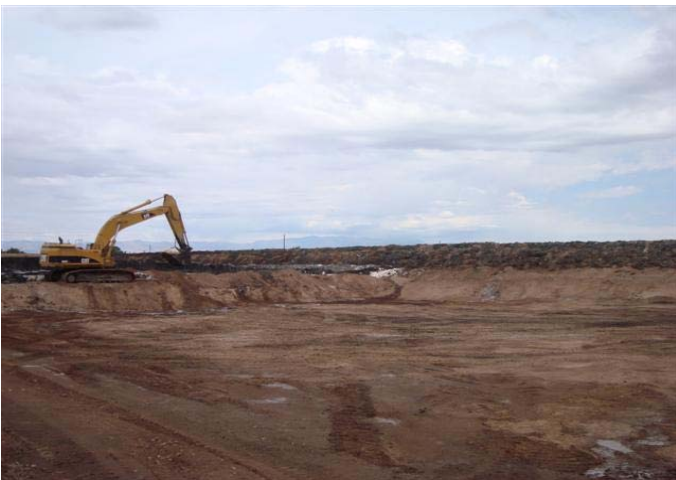
Photo 1

Eastside: SC-1 Pond.

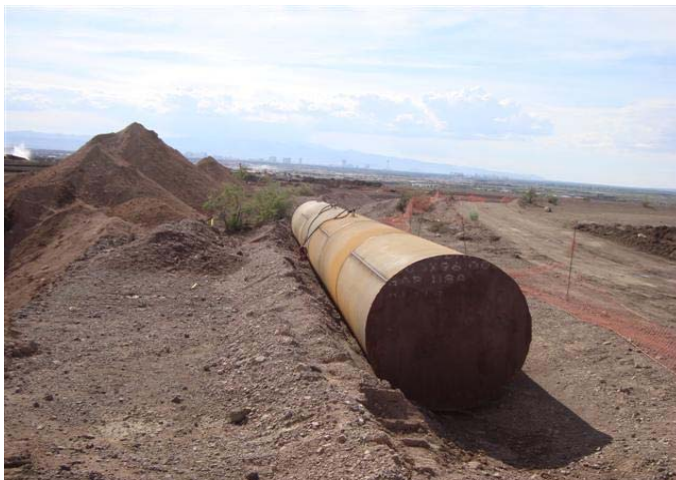
Photo 2

Eastside: Pipe casing.

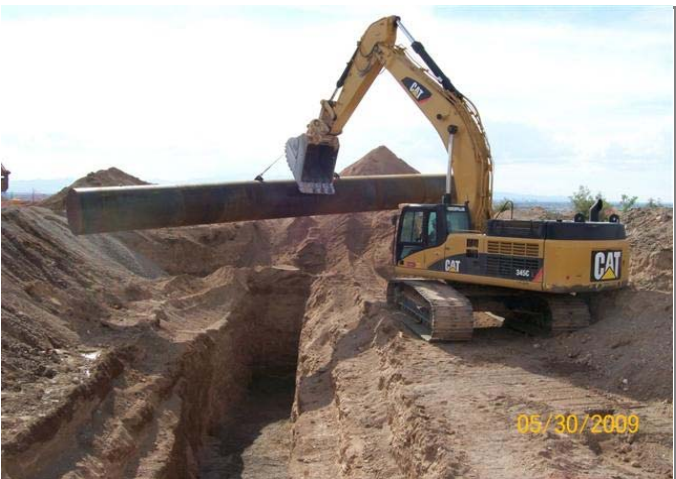
Photo 3

Eastside: Pipe casing.

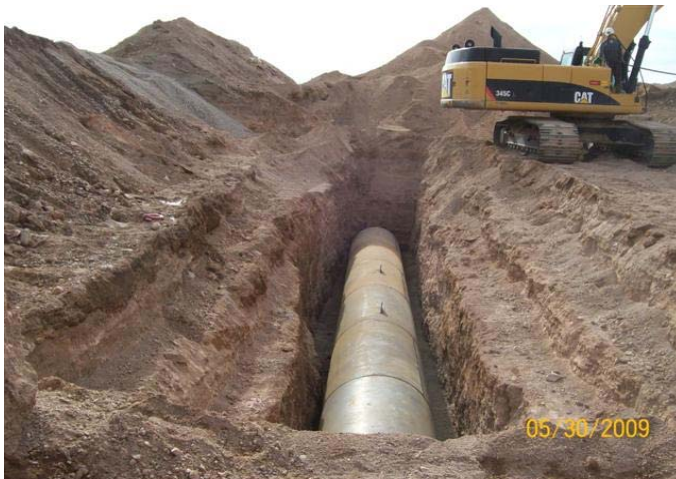
Photo 4

Eastside: Pipe casing.
