DAILY PRODUCTION & QUALITY CONTROL REPORT

Project No./Contract No.	Project Title / Location	Day of Report	Report No.
6389	BRC Eastside Common Areas Soils Remediation	08-Aug-08	43

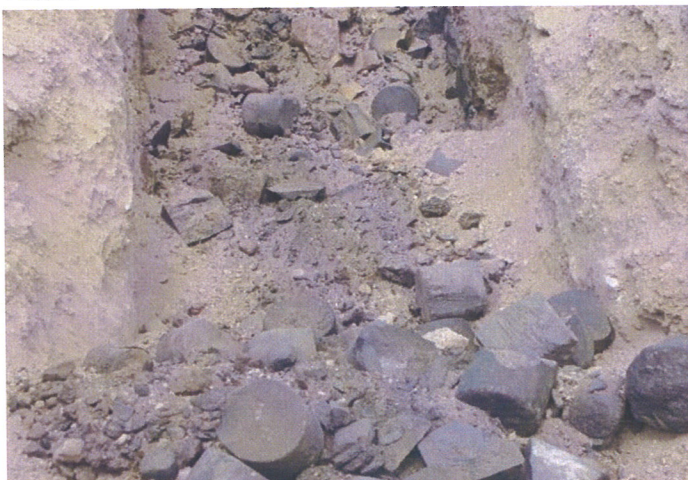
Photo 1

CAMU, Pothole at Northeast Detention Basin.

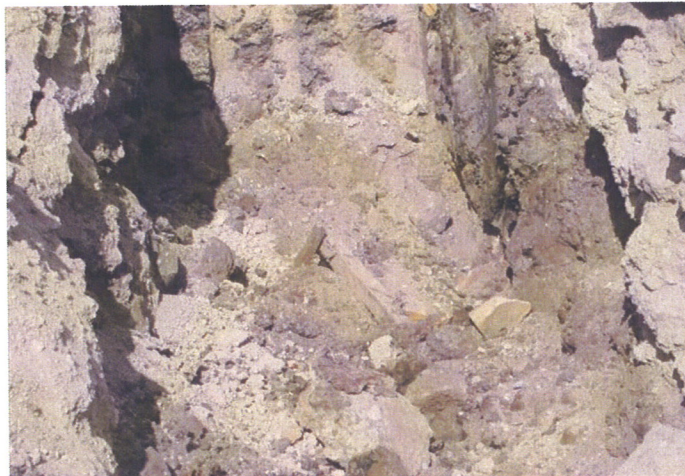
Photo 2

CAMU: Northeast Detention Basin potholing investigation completed. Results: Brick, and concrete debris encountered running East to West connecting holes 12, 15 and 7. Strong odor coming from 12 and 15. Potholes to be backfilled and covered with plastic.

CAMU, Pothole at Northeast Detention Basin. Rubble and Trash

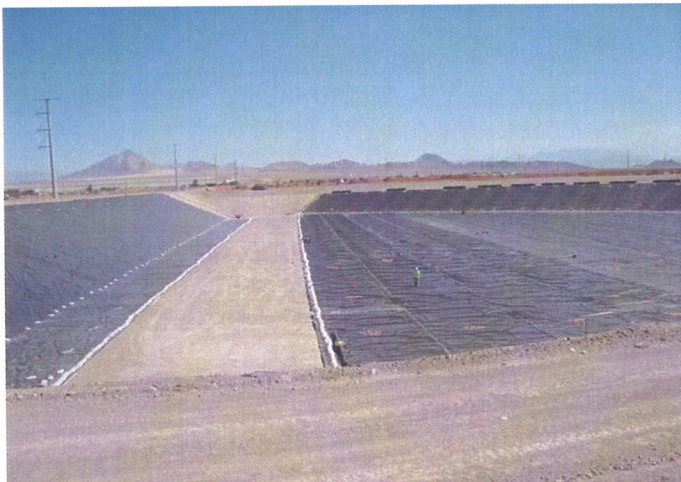
Photo 3

CAMU, Phase 1 Liner Installation.

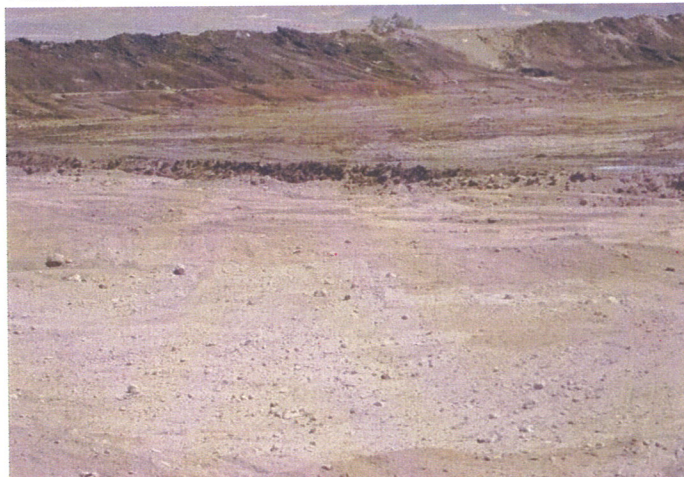
Photo 4

Eastside, SW-6, Final additional excavation below liner, midway.
