# DAILY PRODUCTION & QUALITY CONTROL REPORT

Project No./Contract No.	Project Title / Location	Day of Report	Report No.
6389	<b>BRC Eastside Common Areas Soils Remediation</b>	09-Aug-08	44
		00 7 149 00

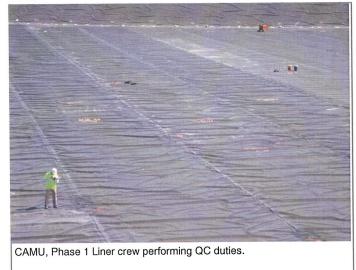
Photo 4

CAMU, Phase 1 Liner crew performing QC duties.
