**DAILY PRODUCTION & QUALITY CONTROL REPORT**

Project No./Contract No.	Project Title / Location	Day of Report	Report No.
6389	BRC Eastside Common Areas Soils Remediation	03-Dec-08	147

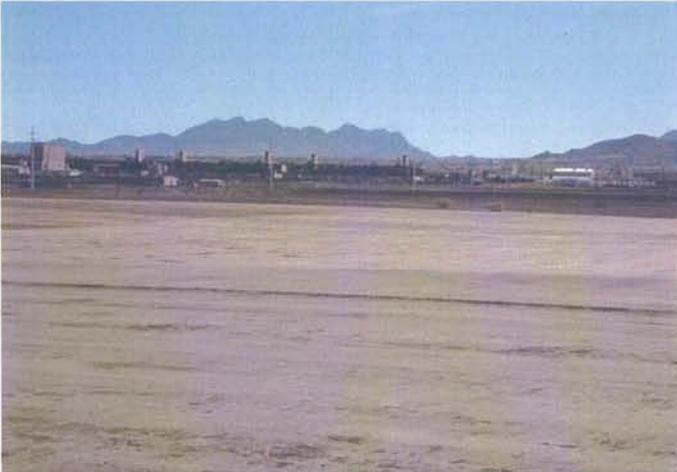
Photo 1

CAMU: BMI North Subgrade in preparation, looking South.

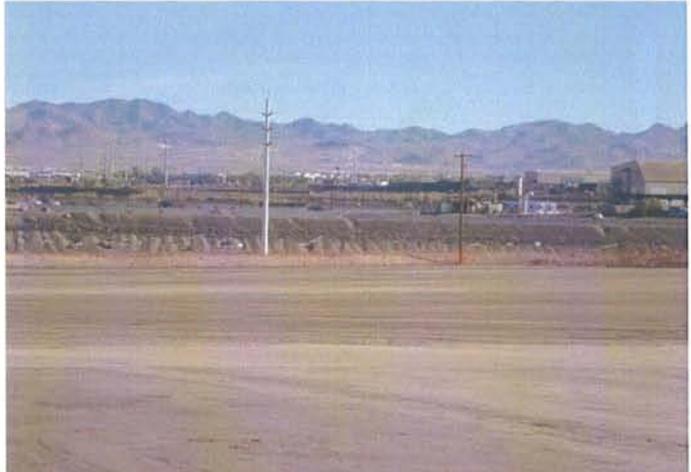
Photo 2

CAMU: BMI North Subgrade in preparation looking Southeast.

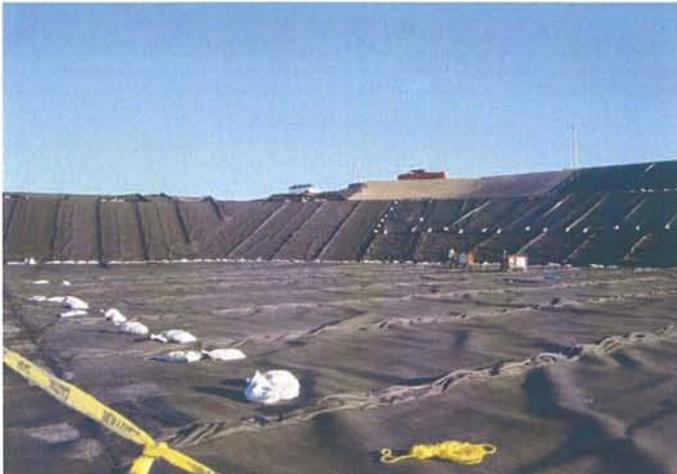
Photo 3

CAMU: Phase II, Geocomposite installed looking Southeast at Phase IIIA bench.

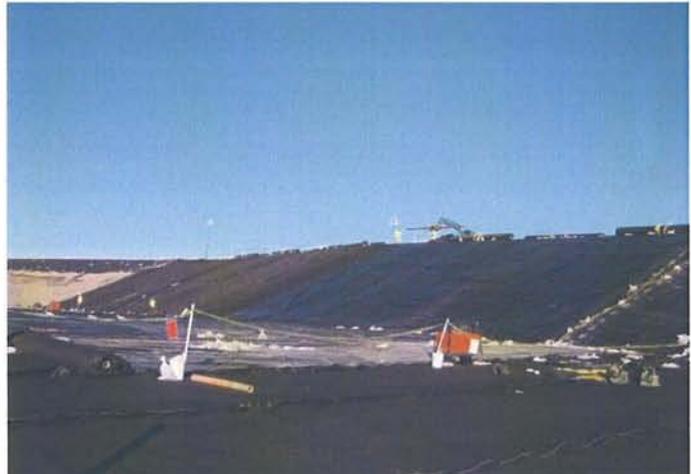
Photo 4

CAMU: Phase II East end.
