DAILY PRODUCTION & QUALITY CONTROL REPORT

Project No./Contract No.	Project Title / Location	Day of Report	Report No.
6389	BRC Eastside Common Areas Soils Remediation	12-Dec-08	156

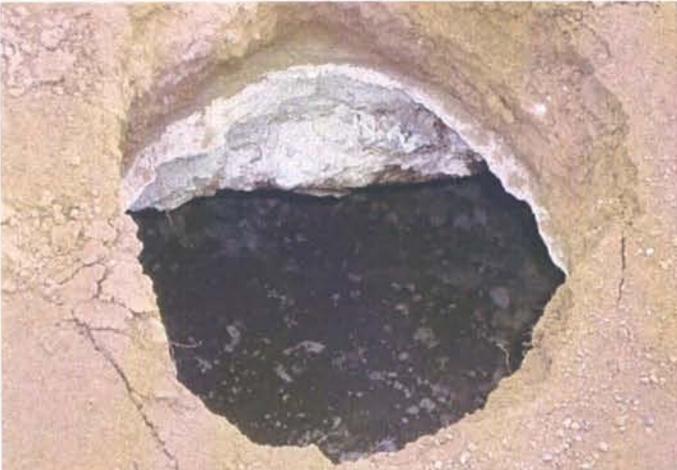
Photo 1

Other: Sinkhole encountered on BMI North Landfill. Proper notifications made. Entact bacfilled and compacted.

CAMU: BMI North Landfill Cap, Sink hole found while compact rolling.

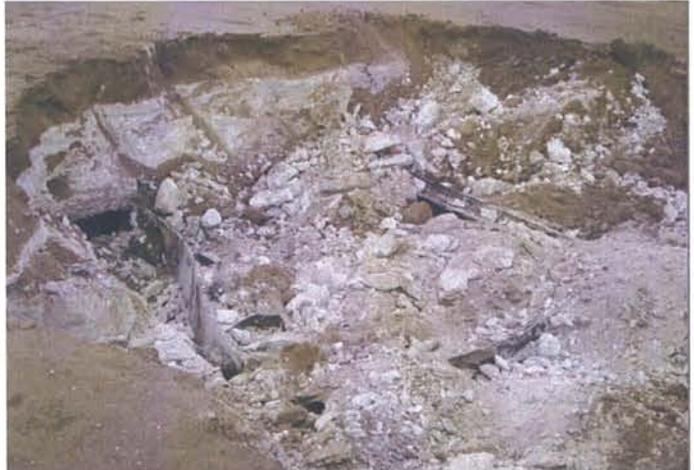
Photo 2

CAMU: BMI North Landfill Cap. Sink hole excavated.

Daily COA Summary.
 Monitored installation of geosynthetics at the BMI North Landfill on the day shift.
 Inspected BMI North Landfill subgrade for liner.
 Continued review of and updating of project documents and database to facilitate reporting.
 Monitored backfill compaction of sinkhole encountered on BMI North Landfill.

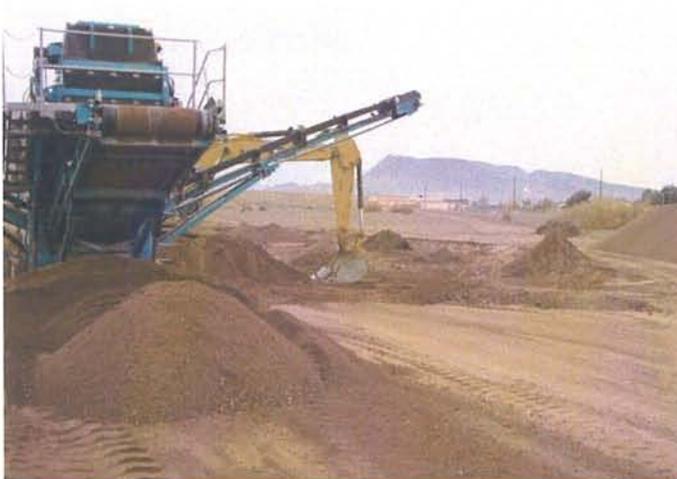
Photo 3

Eastside: Excavating and powerscreening WST-8, .

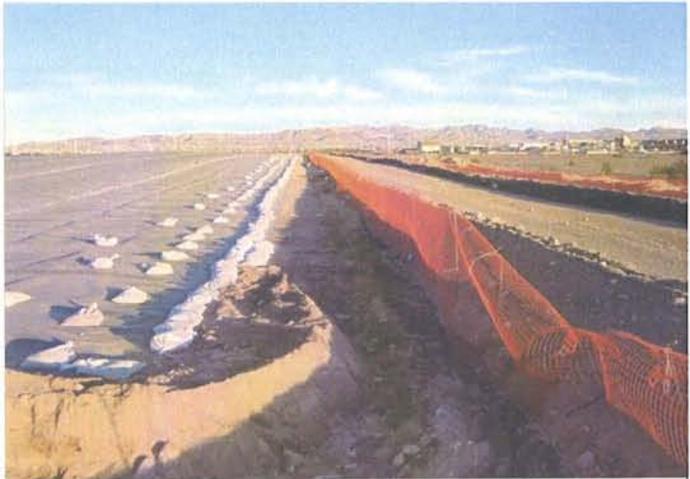
Photo 4

CAMU: BMI North Landfill, southwest corner prepared for rain.
