## DAILY PRODUCTION & QUALITY CONTROL REPORT

Project No./Contract No.	Project Title / Location	Day of Report	Report No.
6389	BRC Eastside Common Areas Soils Remediation	23-Jan-09	194

### DAILY PHOTO LOG

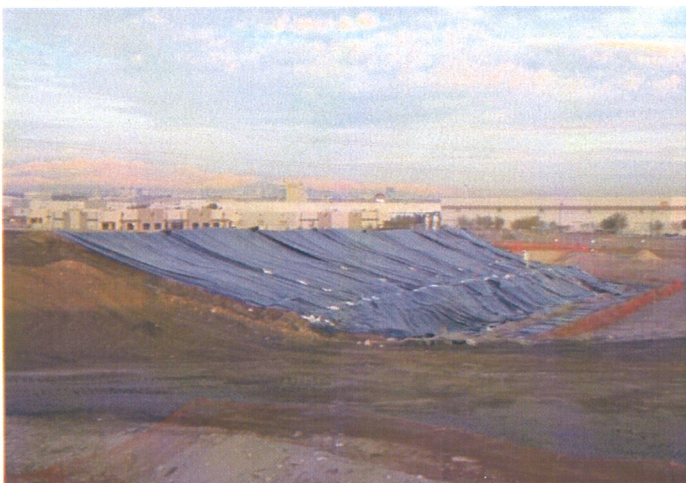
Photo 1

CAMU: Phase I, Visqueen placement North slope.

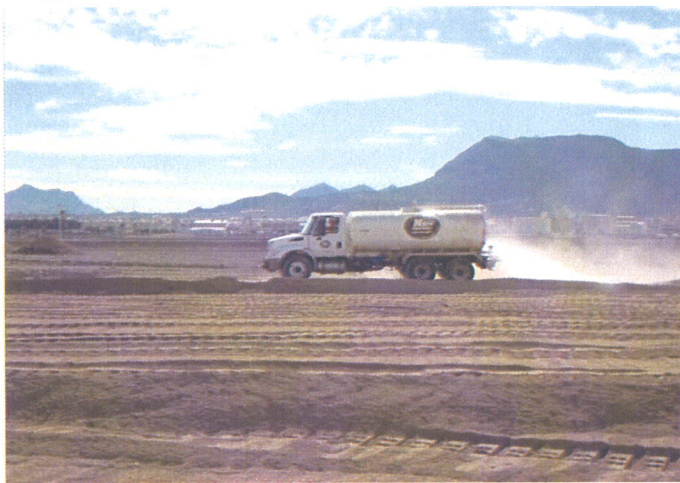
Photo 2

CAMU: North BMI Landfill, dust control on cover soils.

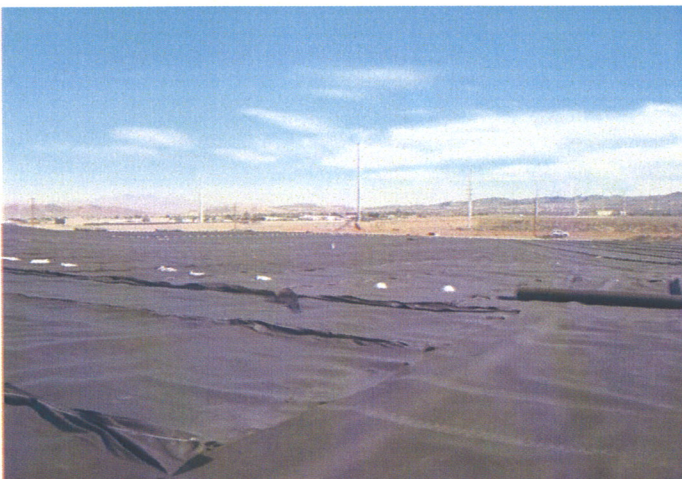
Photo 3

CAMU: North BMI Landfill, geocomposite liner installation, looking east.

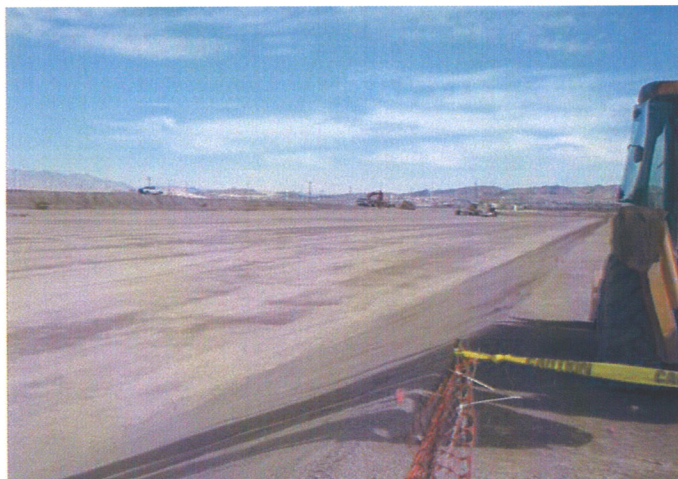
Photo 4

CAMU: Phase IIIA subgrade, looking east.
