BMI Common Areas (Eastside)  
Clark County, Nevada  
FIGURE I-1B

ALUMINUM SOIL RESULTS  
IN GALLERIA NORTH  
SCHOOL SITE SUB-AREA

Prepared by  
MKJ (ERM)

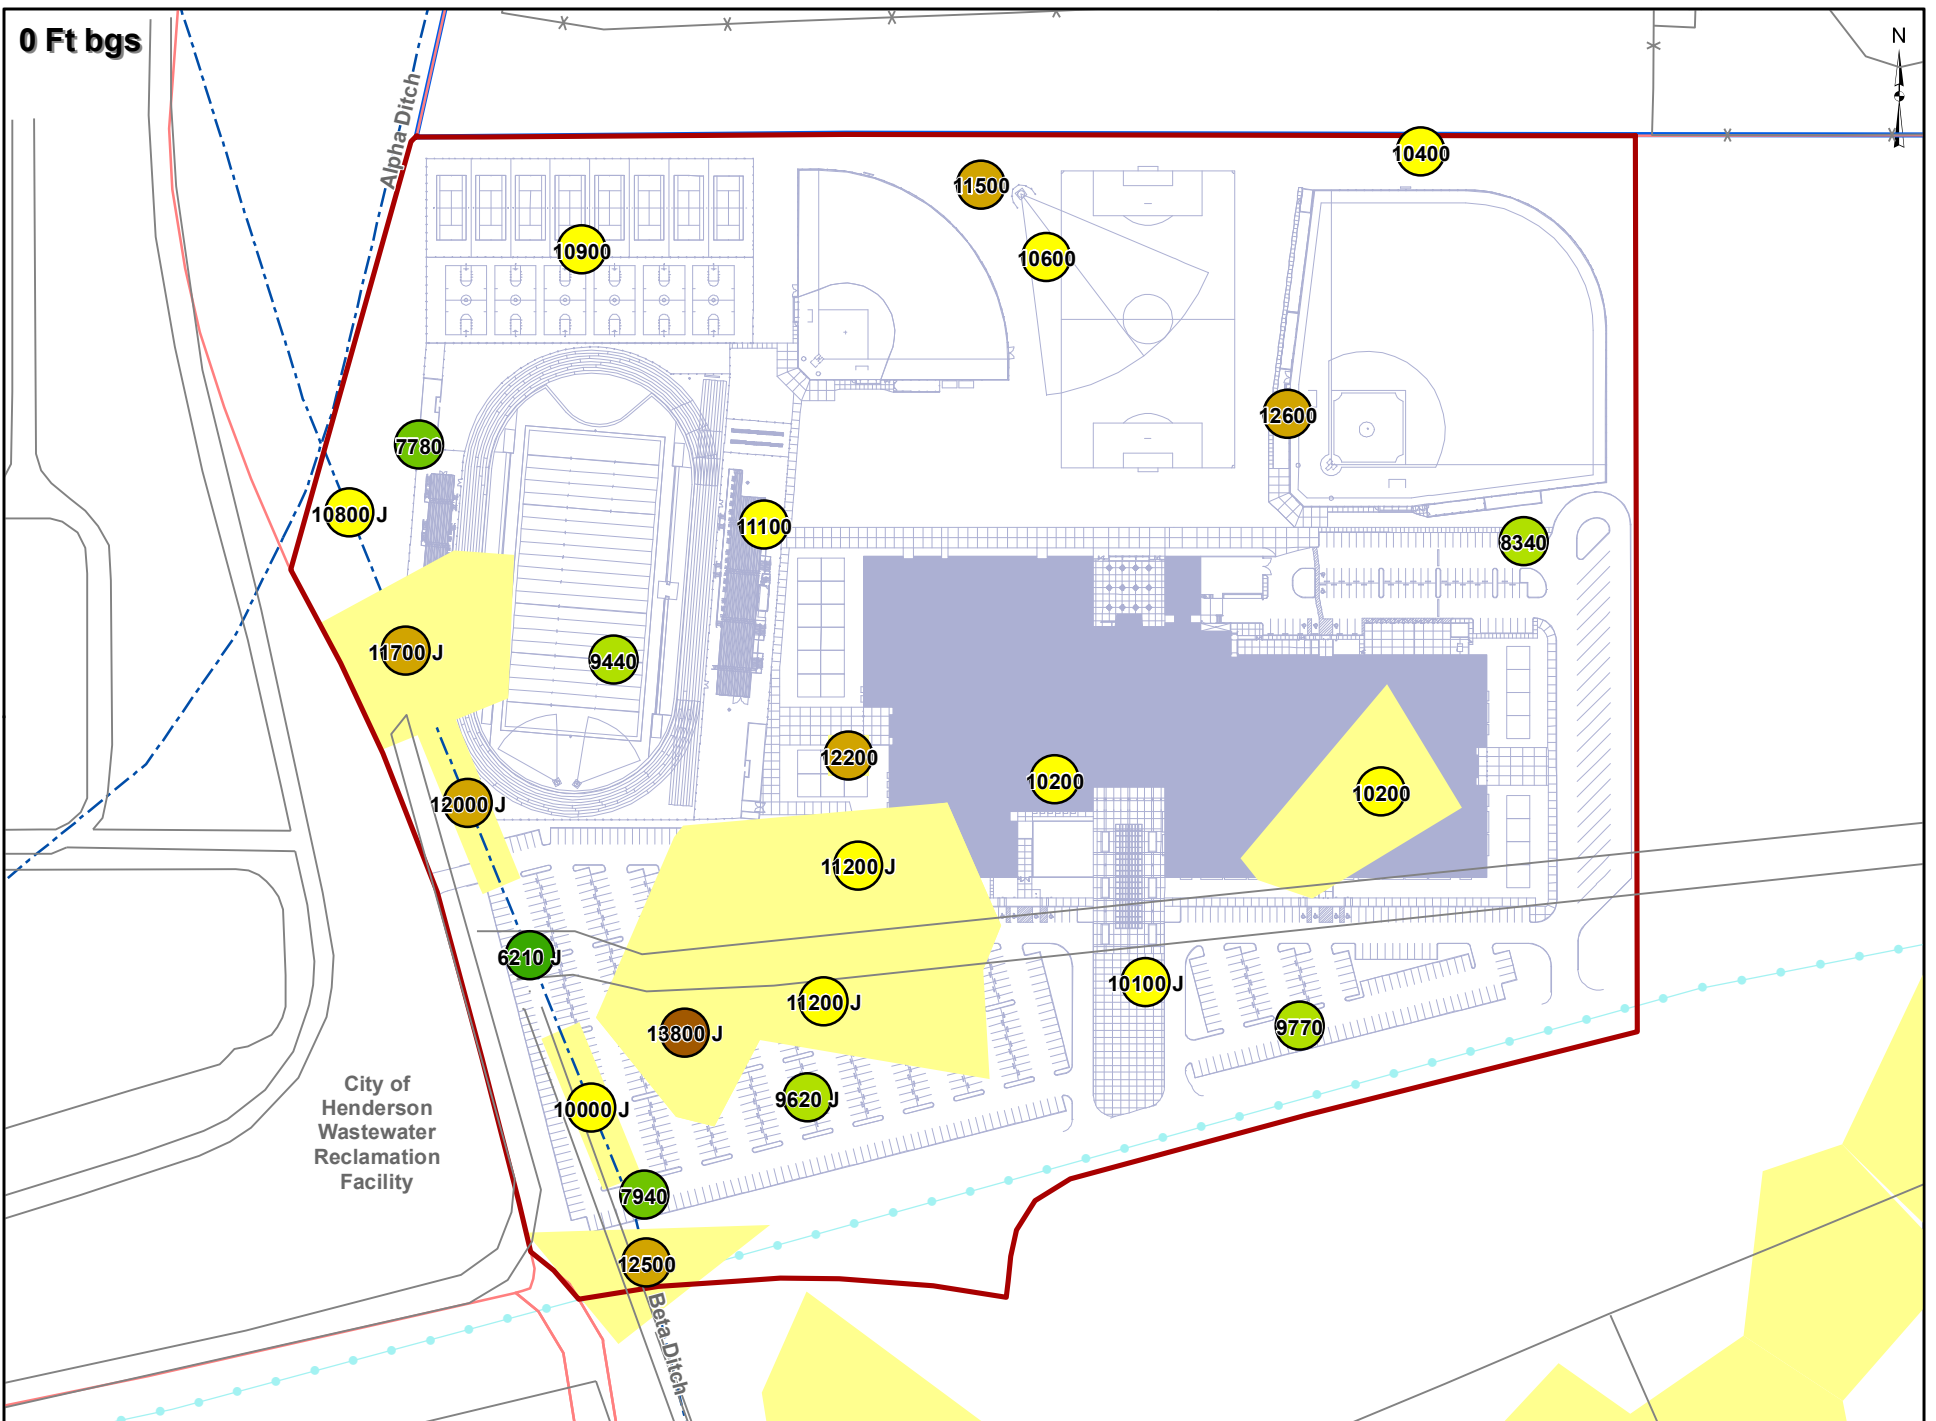
Note: Results shown are those used in the human health risk assessment. Standard deviations are calculated by ArcGIS using the statistical value field from the database (includes both detect and non-detect results).

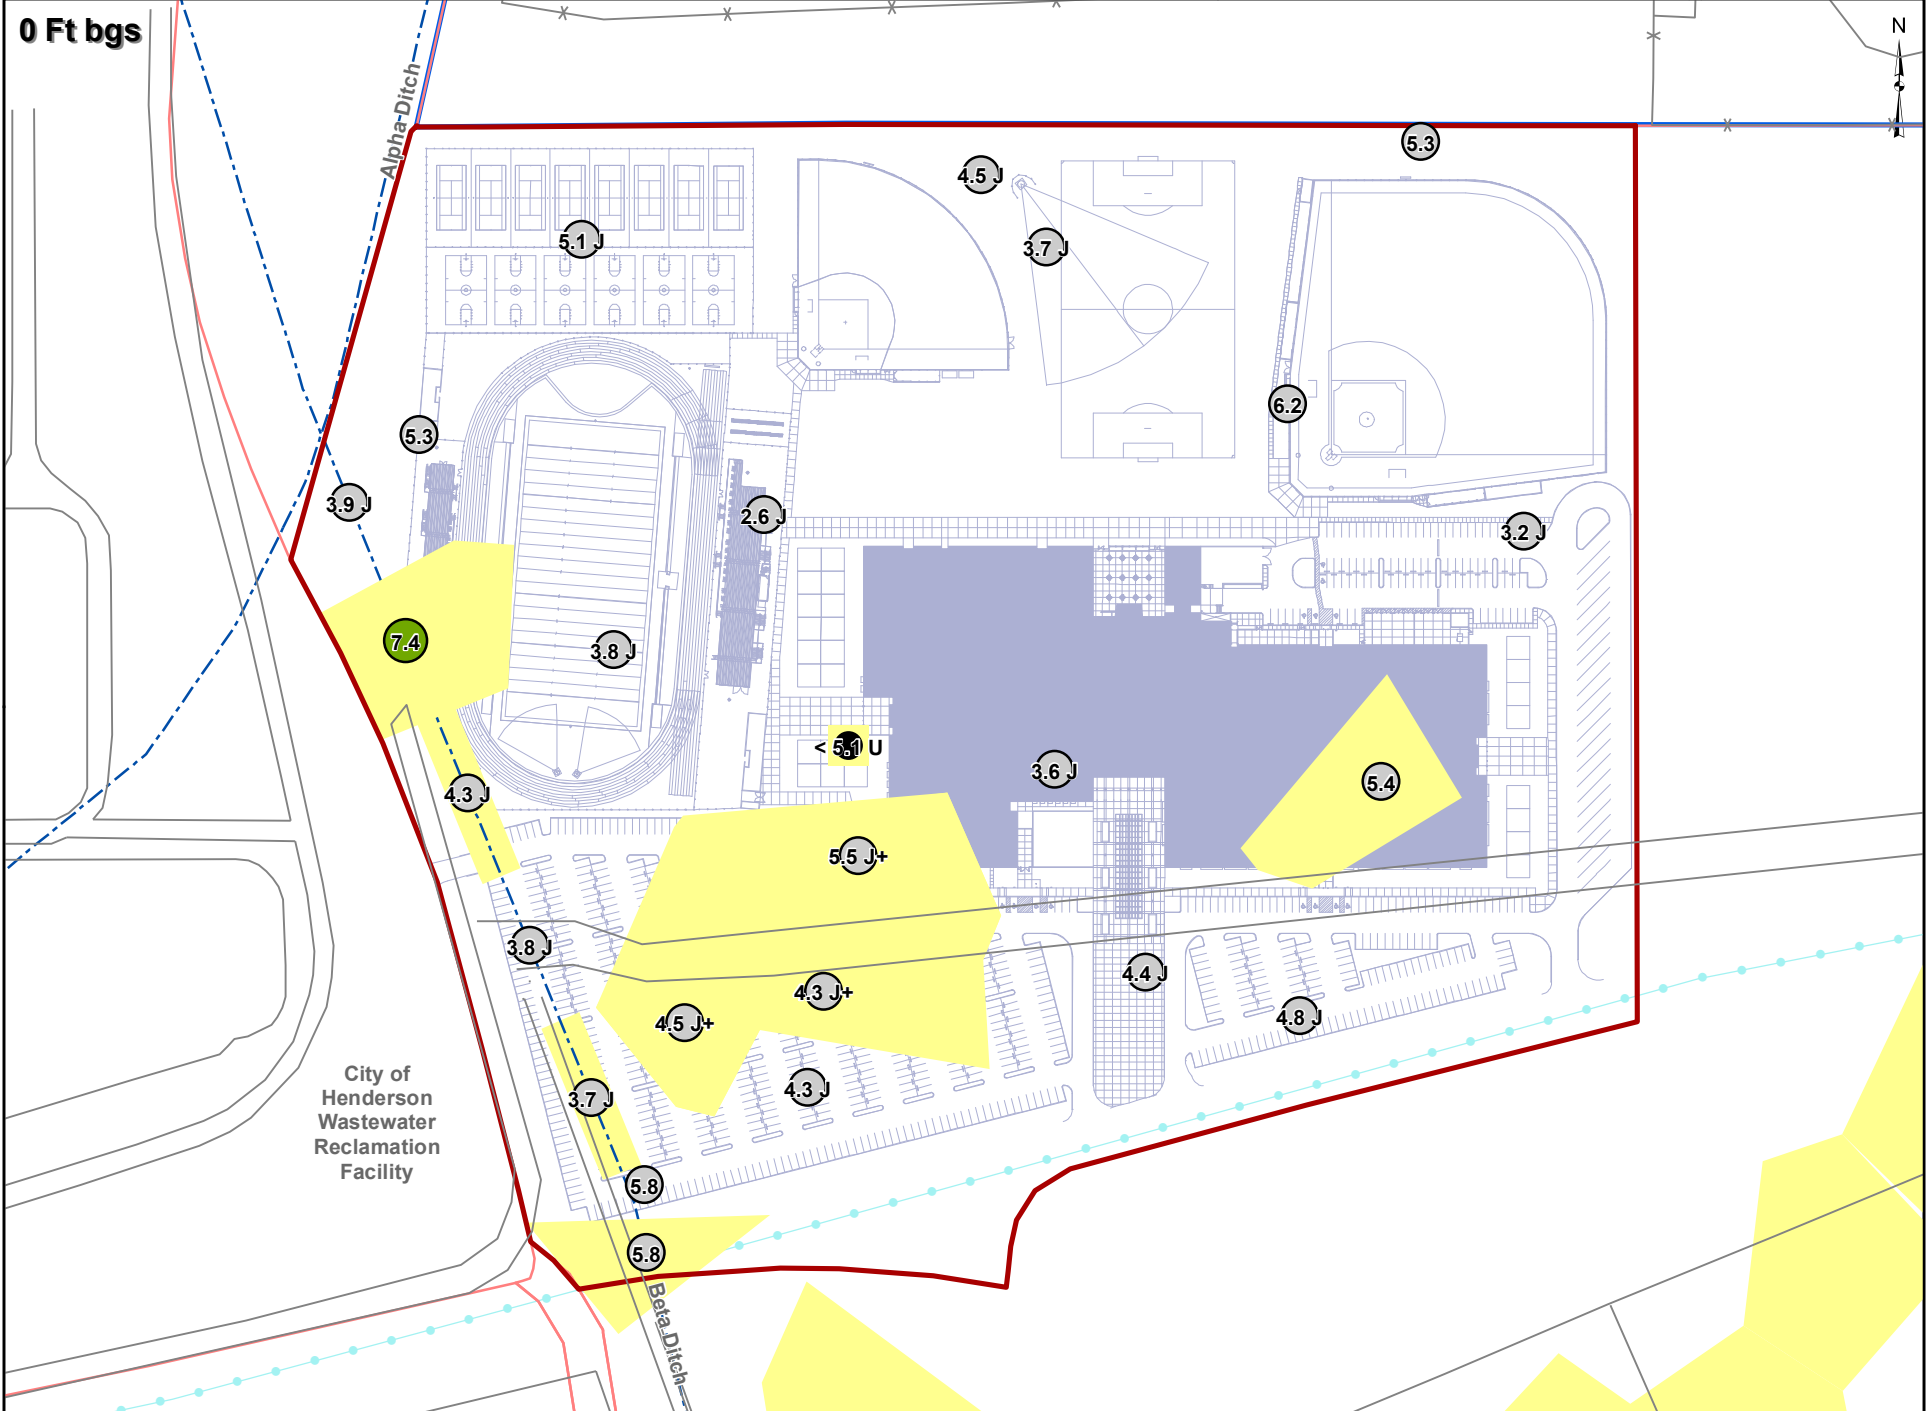
BMI Common Areas (Eastside)  
Clark County, Nevada  
FIGURE I-3A

- Non-Detect
- < Max. Shallow Background (7.2 mg/kg)
- >= Max. Shallow Background and < Max. Deep Background
- >= Max. Deep Background (13.1 mg/kg)

Note: Results shown are those used in the human health risk assessment. Comparison values (BCLs, max. back-ground) are presented in Table 4.

ARSENIC SOIL RESULTS  
IN GALLERIA NORTH  
SCHOOL SITE SUB-AREA

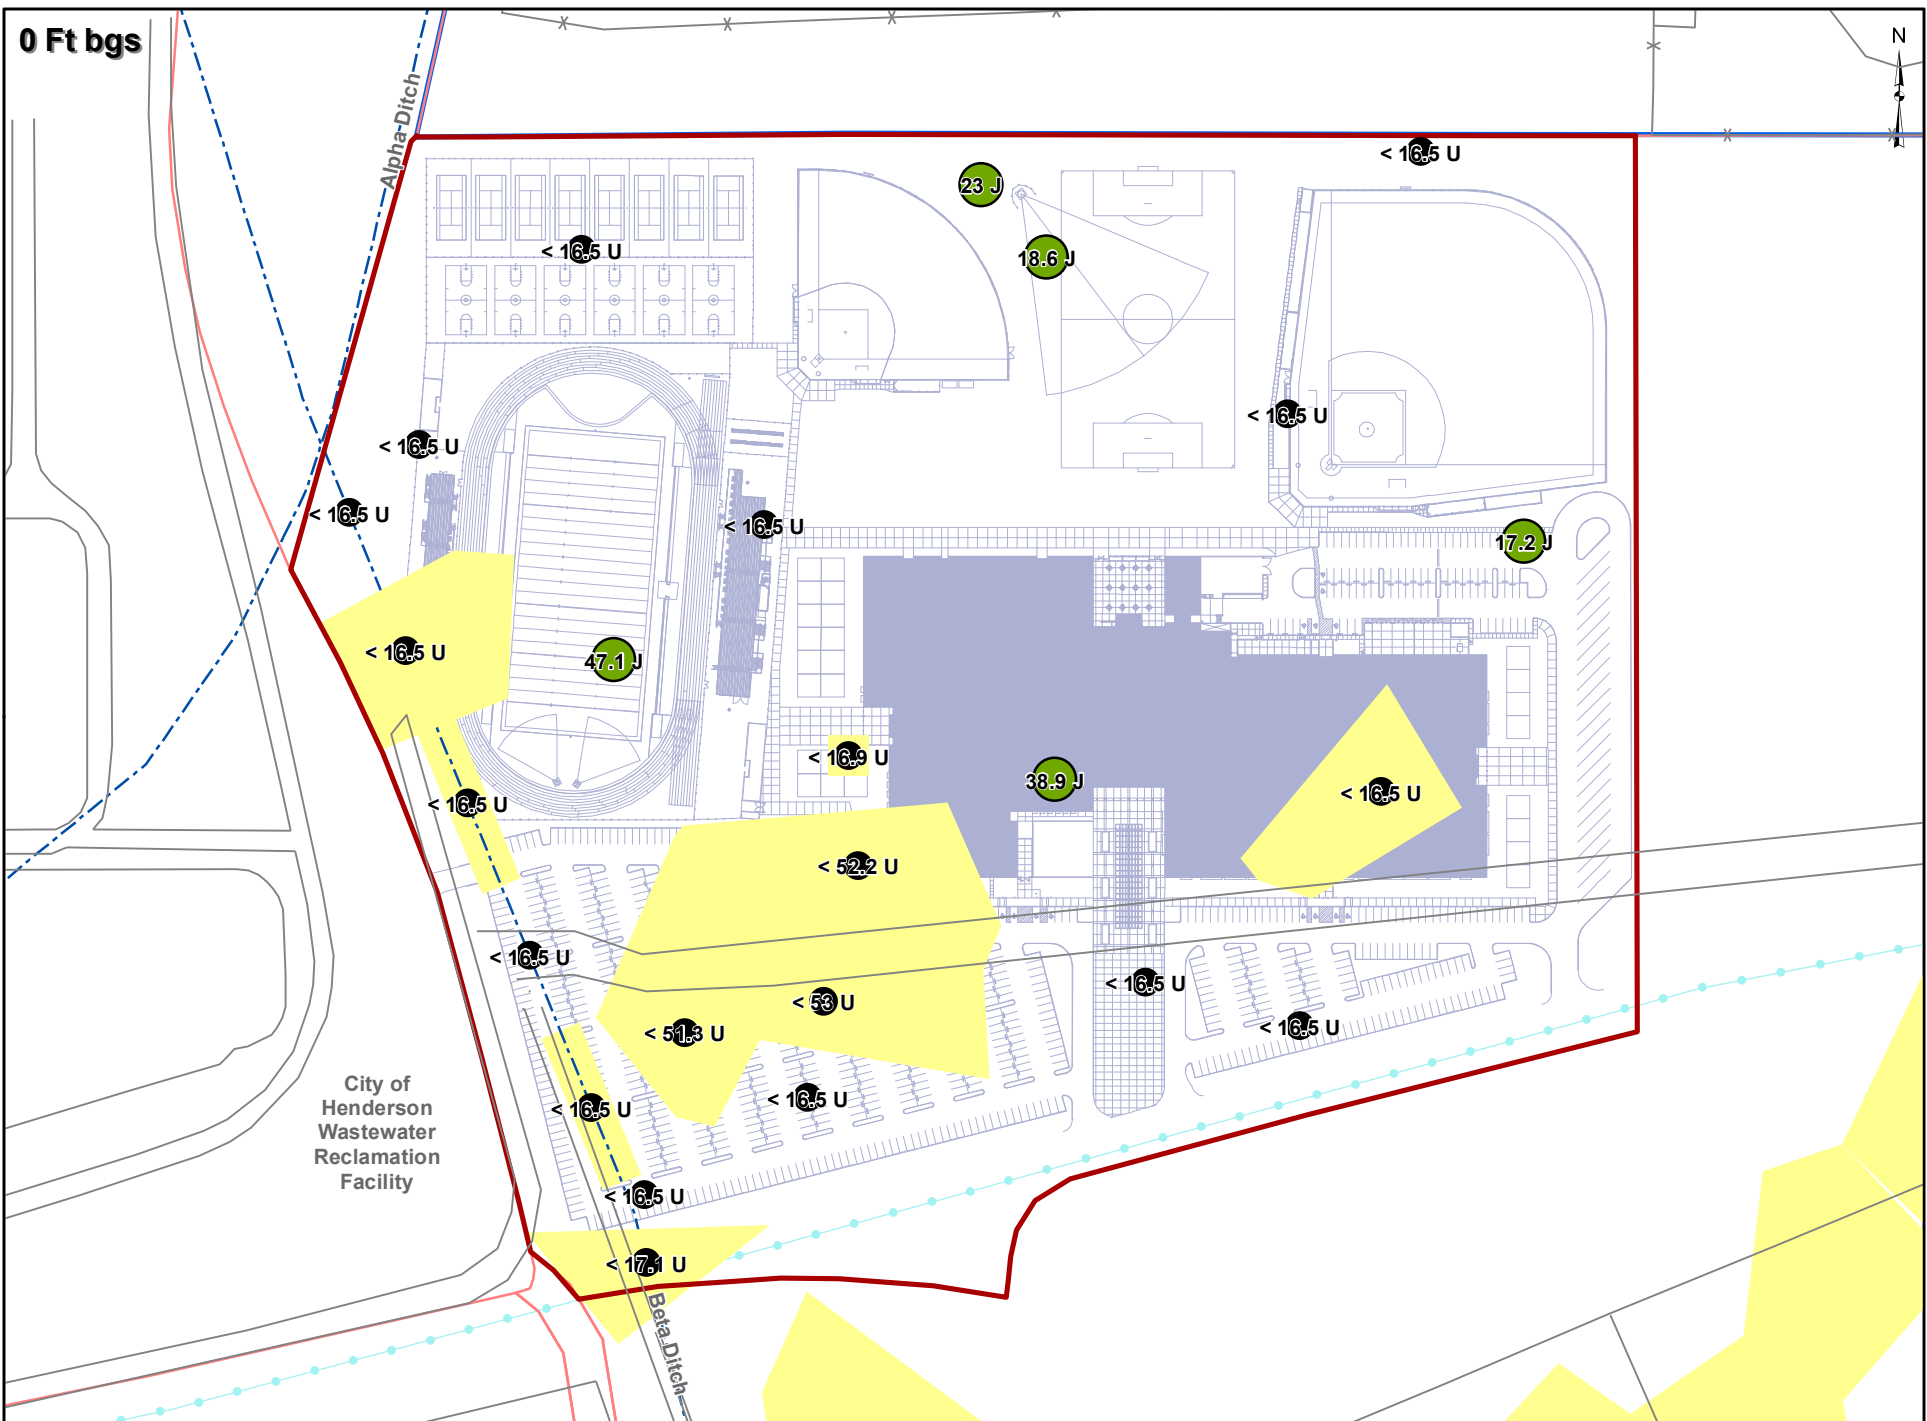
0 Ft bgs

<div><div></div> Galleria North-School Site Sub-Area</div> <div><div></div> Site AOC3 Boundary</div> <div><div></div> Eastside Soil Sub-Areas</div> <div><div></div> Recent Soil Removal Areas</div>	<div><div></div> Non-Detect</div> <div><div></div> &lt; Max. Shallow Background</div> <div><div></div> &gt;= Max. Shallow Background and &lt; Residential BCL</div> <div><div></div> &gt;= Residential BCL</div>	<div>Note: Results shown are those used in the human health risk assessment. Comparison values (BCLs, max. back-ground) are presented in Table 4.</div> <div><div>Prepared by MKJ (ERM)</div><div>Date 11/10/10</div><div>JOB No. 0064276 FILE: GIS/BRC/GALLERIA-NORTH/APPENDIX_I.MXD</div></div> <div><div>BORON SOIL RESULTS IN GALLERIA NORTH SCHOOL SITE SUB-AREA</div><div><div>BMI Common Areas (Eastside) Clark County, Nevada</div><div>FIGURE I-6A</div><div>Basic Remediation COMPANY</div></div></div>

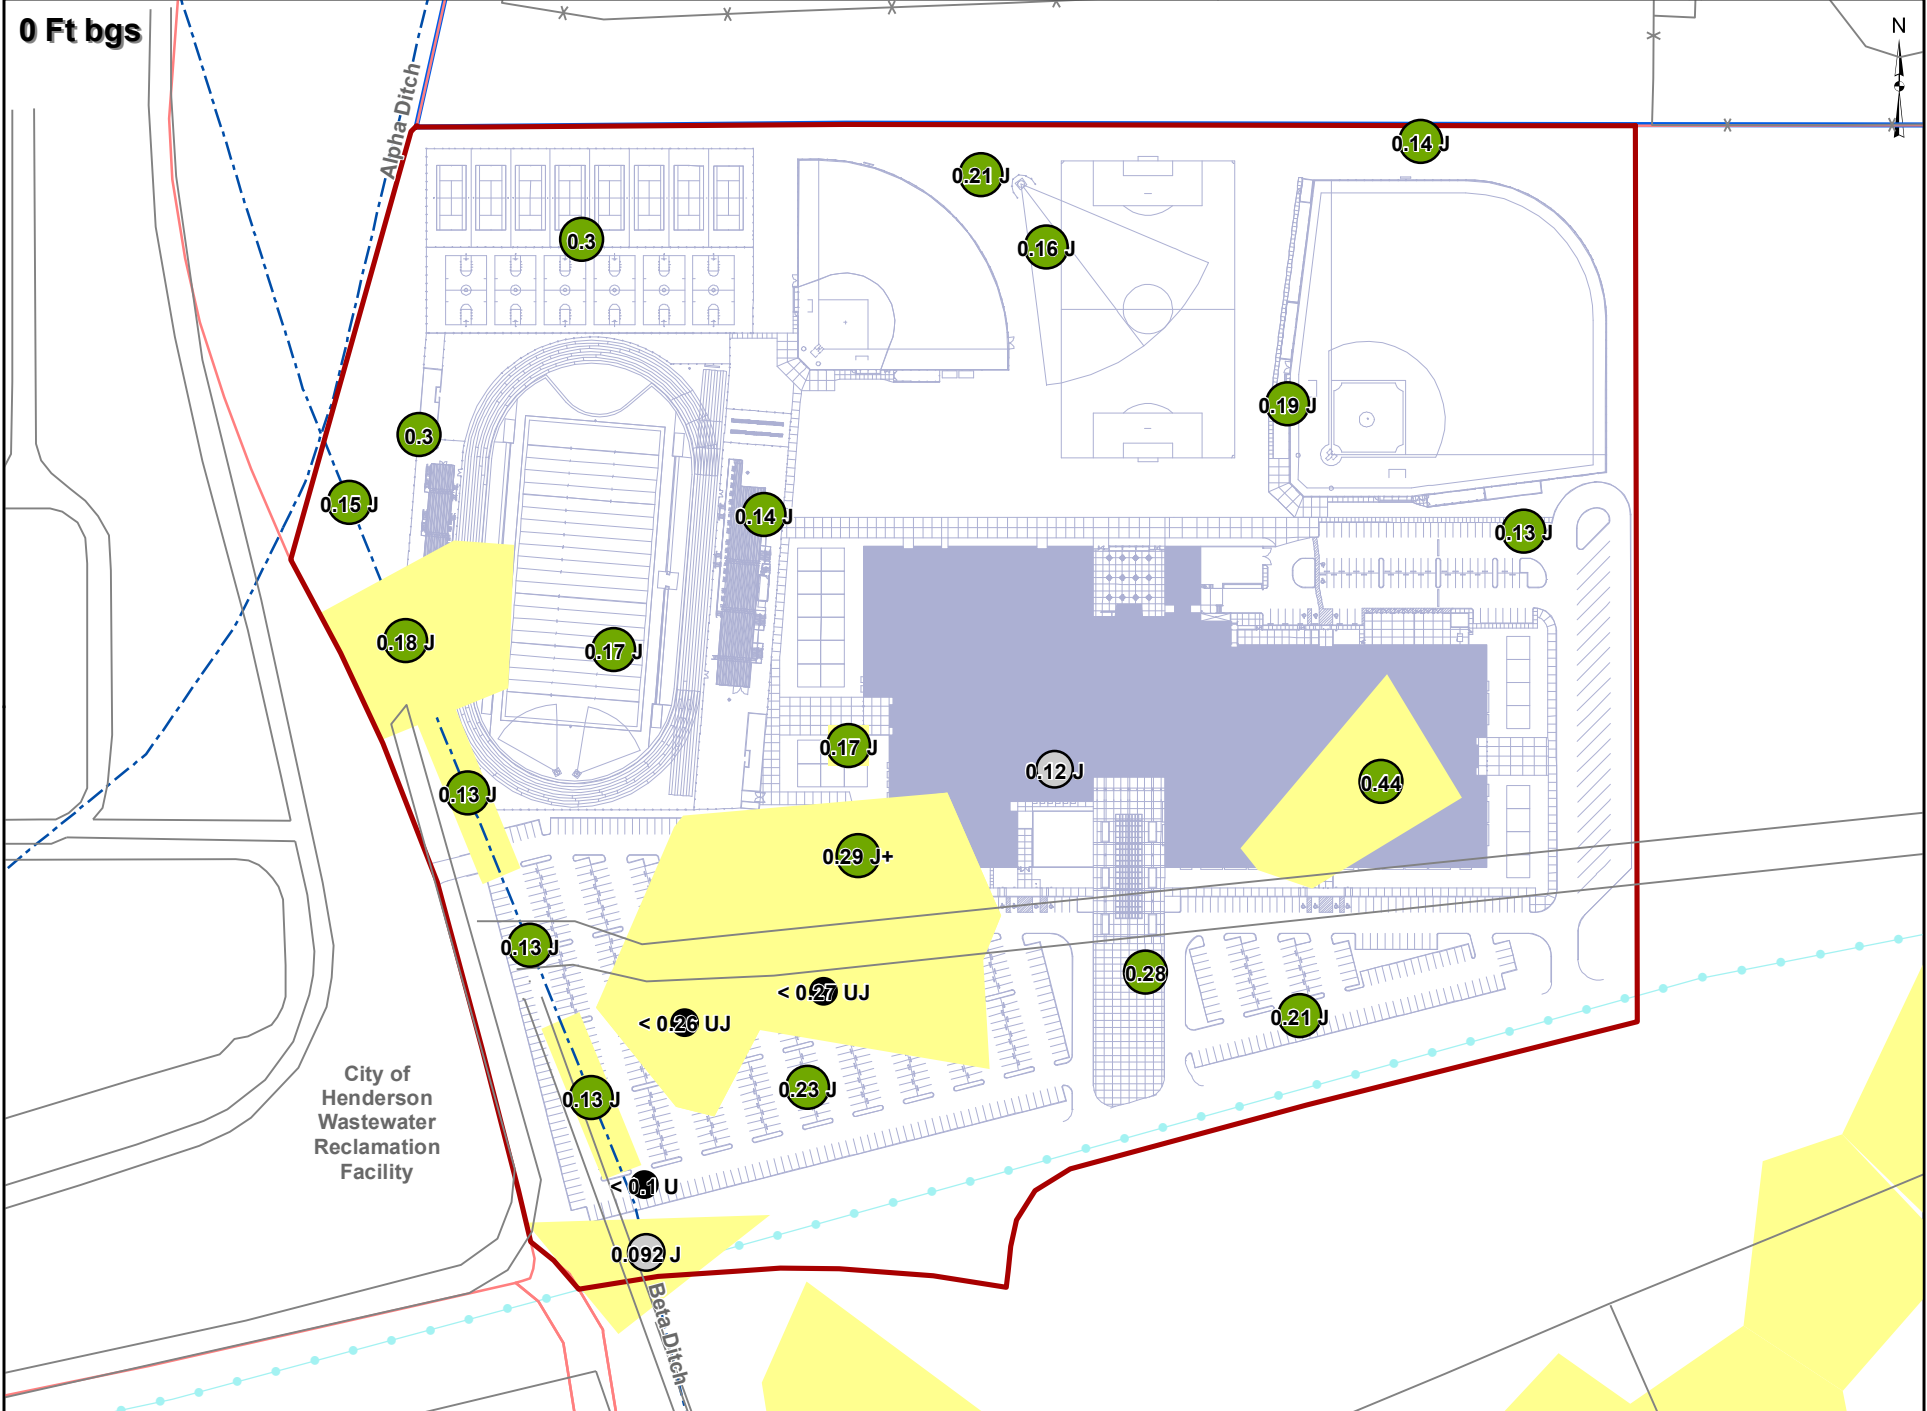
Galleria North-School Site Sub-Area	Non-Detect	<p>Note: Results shown are those used in the human health risk assessment. Comparison values (BCLs, max. back-ground) are presented in Table 4.</p>	<p>BMI Common Areas (Eastside) Clark County, Nevada FIGURE I-7A</p> <p><b>CADMIUM SOIL RESULTS IN GALLERIA NORTH SCHOOL SITE SUB-AREA</b></p> <p>Prepared by MKJ (ERM)</p> <p>Date 11/10/10</p> <p>JOB No. 0064276 FILE: GIS/BCR/GALLERIA-NORTH/APPENDIX_I.MXD</p>
Site AOC3 Boundary	< Max. Shallow Background		
Eastside Soil Sub-Areas	>= Max. Shallow Background and < Residential BCL		
Recent Soil Removal Areas	>= Residential BCL

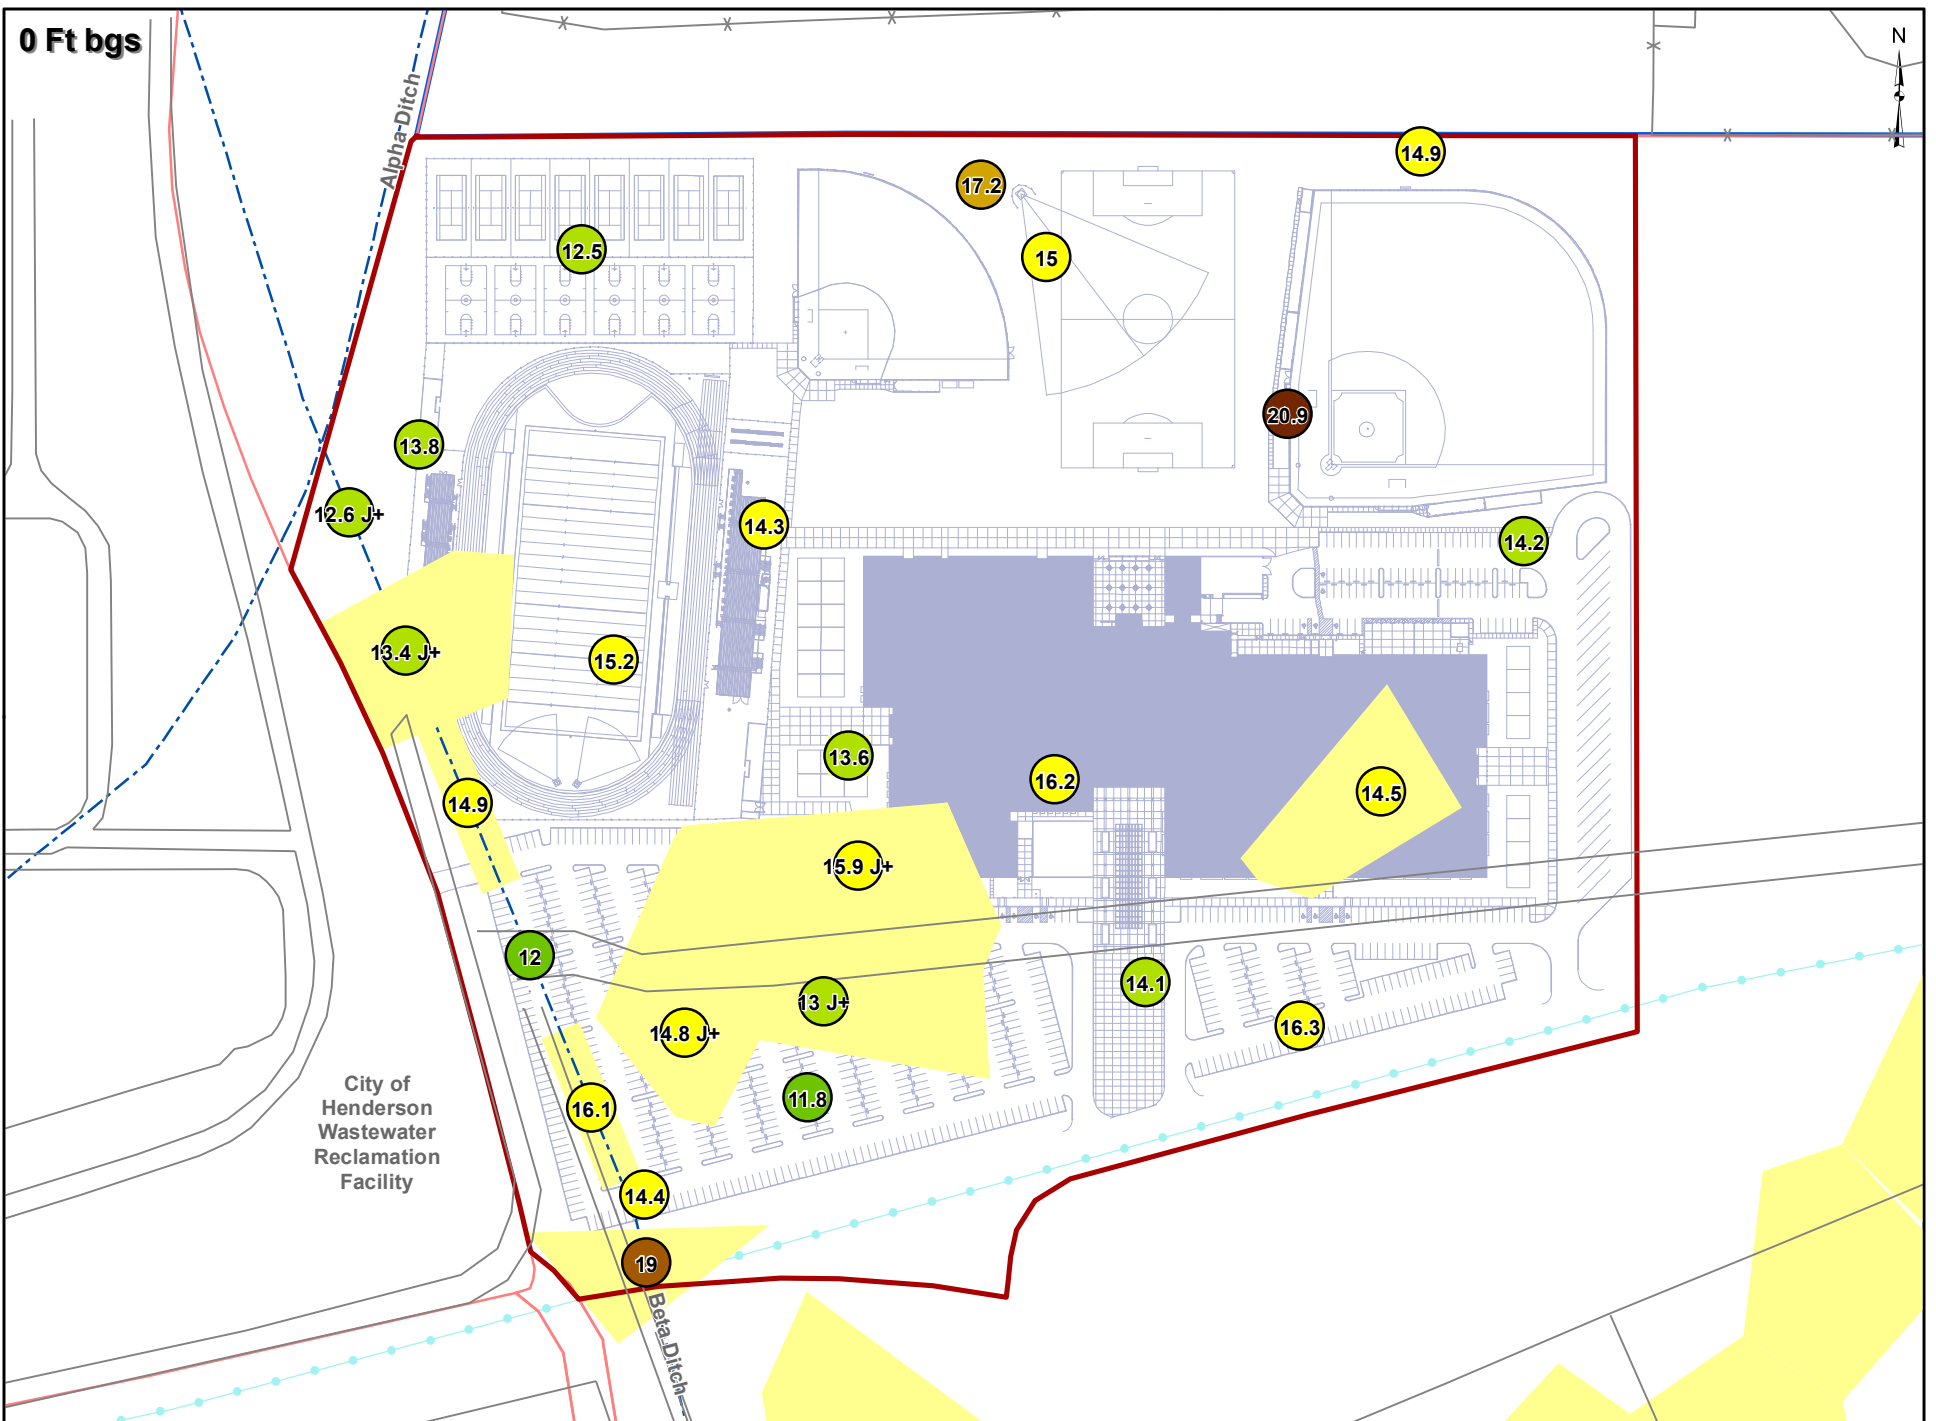
BMI Common Areas (Eastside)  
Clark County, Nevada  
FIGURE I-15B

Note: Results shown are those used in the human health risk assessment. Standard deviations are calculated by ArcGIS using the statistical value field from the database (includes both detect and non-detect results).

LITHIUM SOIL RESULTS  
IN GALLERIA NORTH  
SCHOOL SITE SUB-AREA

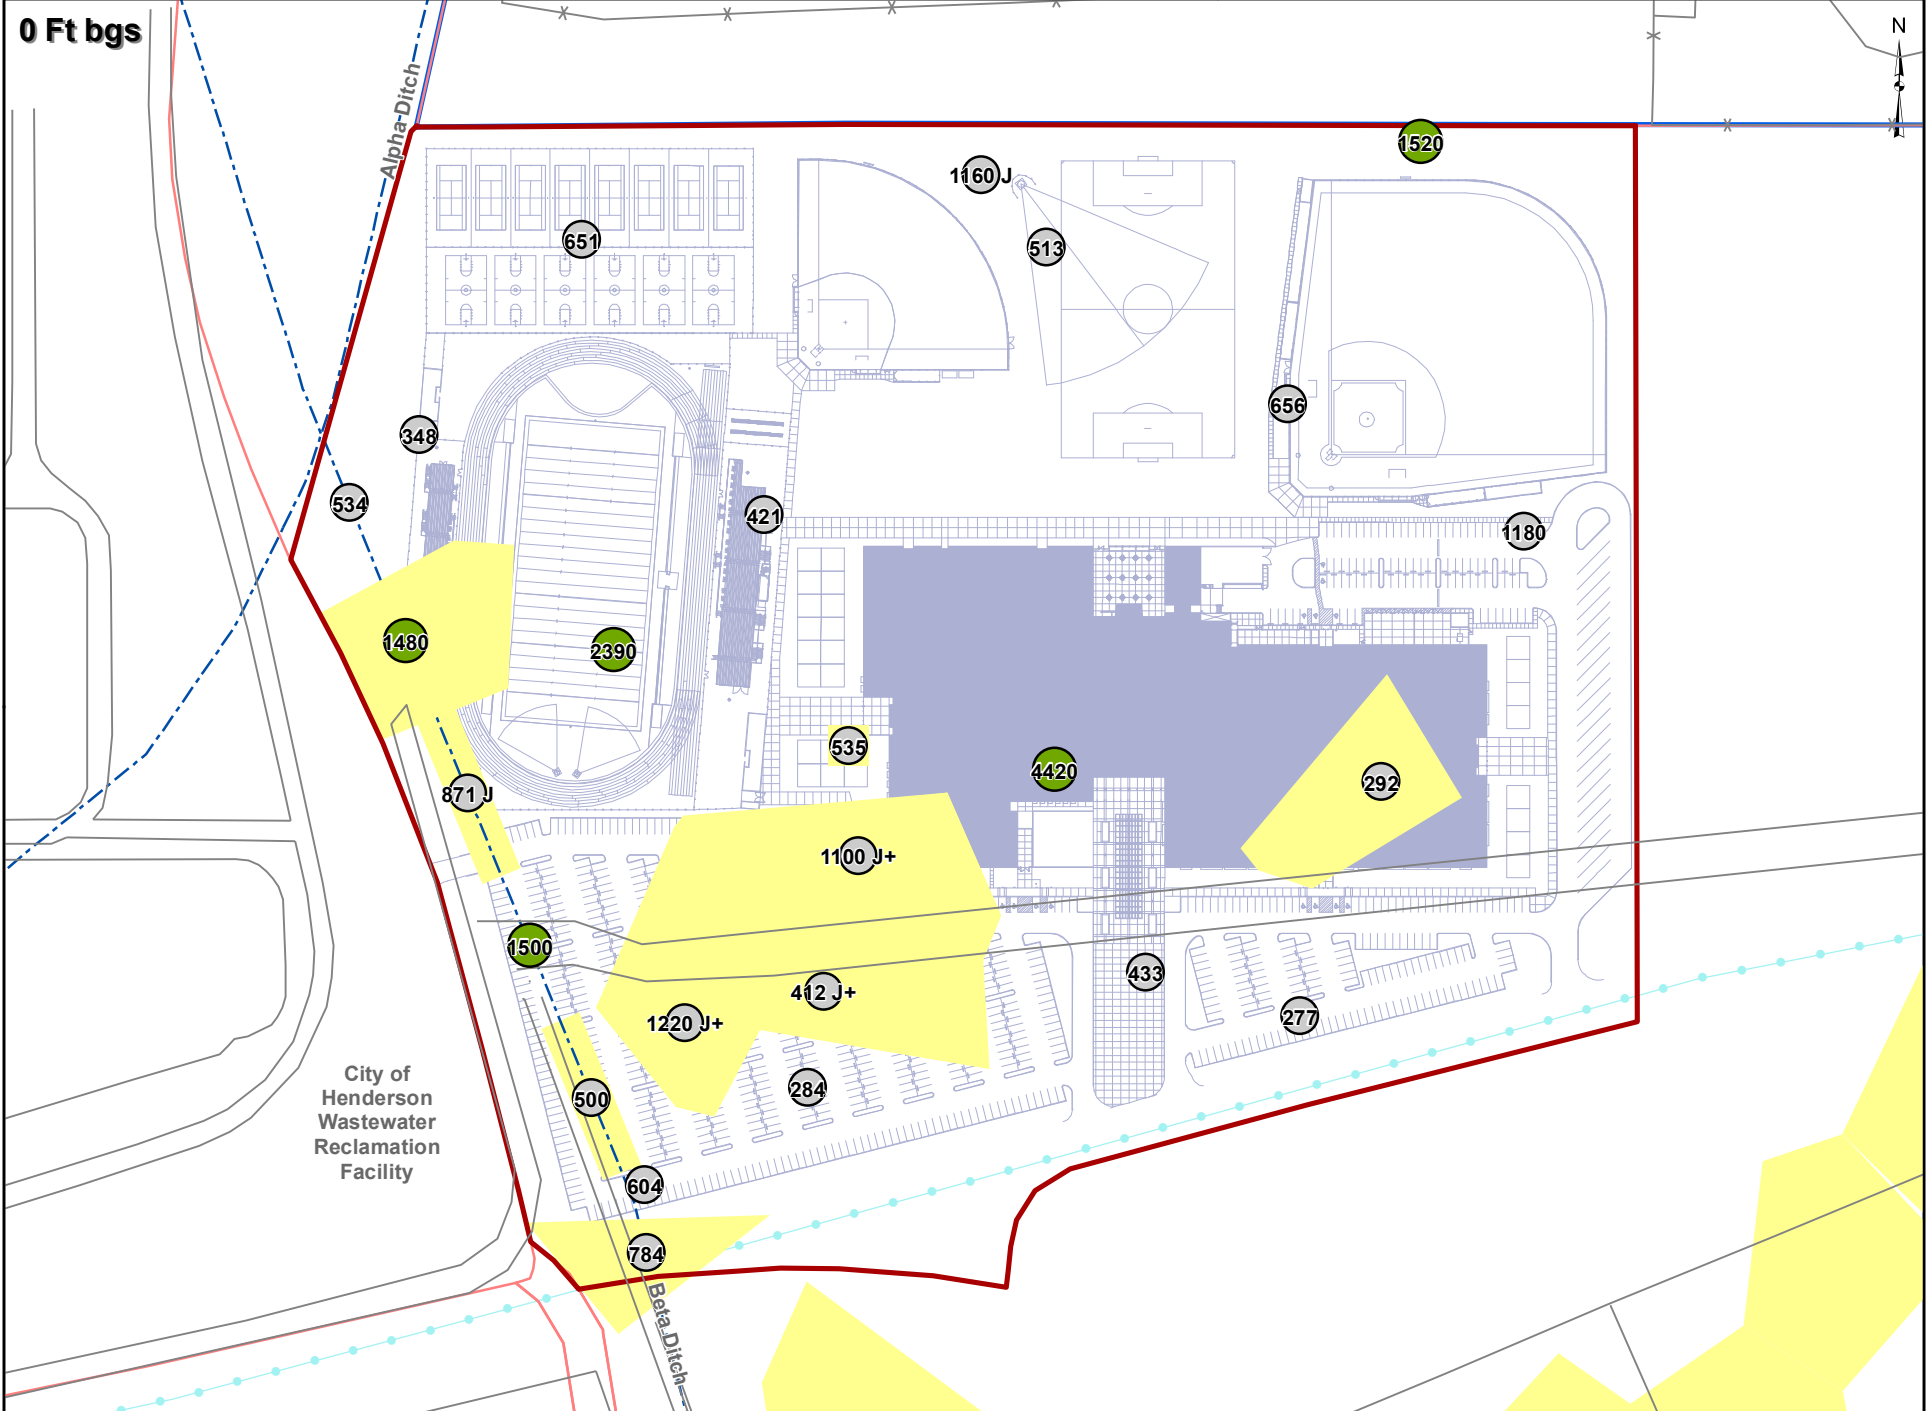
Galleria North-School Site Sub-Area	Non-Detect	<p>Note: Results shown are those used in the human health risk assessment. Comparison values (BCLs, max. back-ground) are presented in Table 4.</p>	<p>BMI Common Areas (Eastside) Clark County, Nevada FIGURE I-24A</p> <p><b>SODIUM SOIL RESULTS IN GALLERIA NORTH SCHOOL SITE SUB-AREA</b></p> <p>Prepared by MKJ (ERM)</p> <p>Date 11/10/10</p> <p>JOB No. 0064276 FILE: GIS/BCR/GALLERIA-NORTH/APPENDIX_I.MXD</p>
Site AOC3 Boundary	< Max. Shallow Background		
Eastside Soil Sub-Areas	>= Max. Shallow Background and < Residential BCL		
Recent Soil Removal Areas	>= Residential BCL

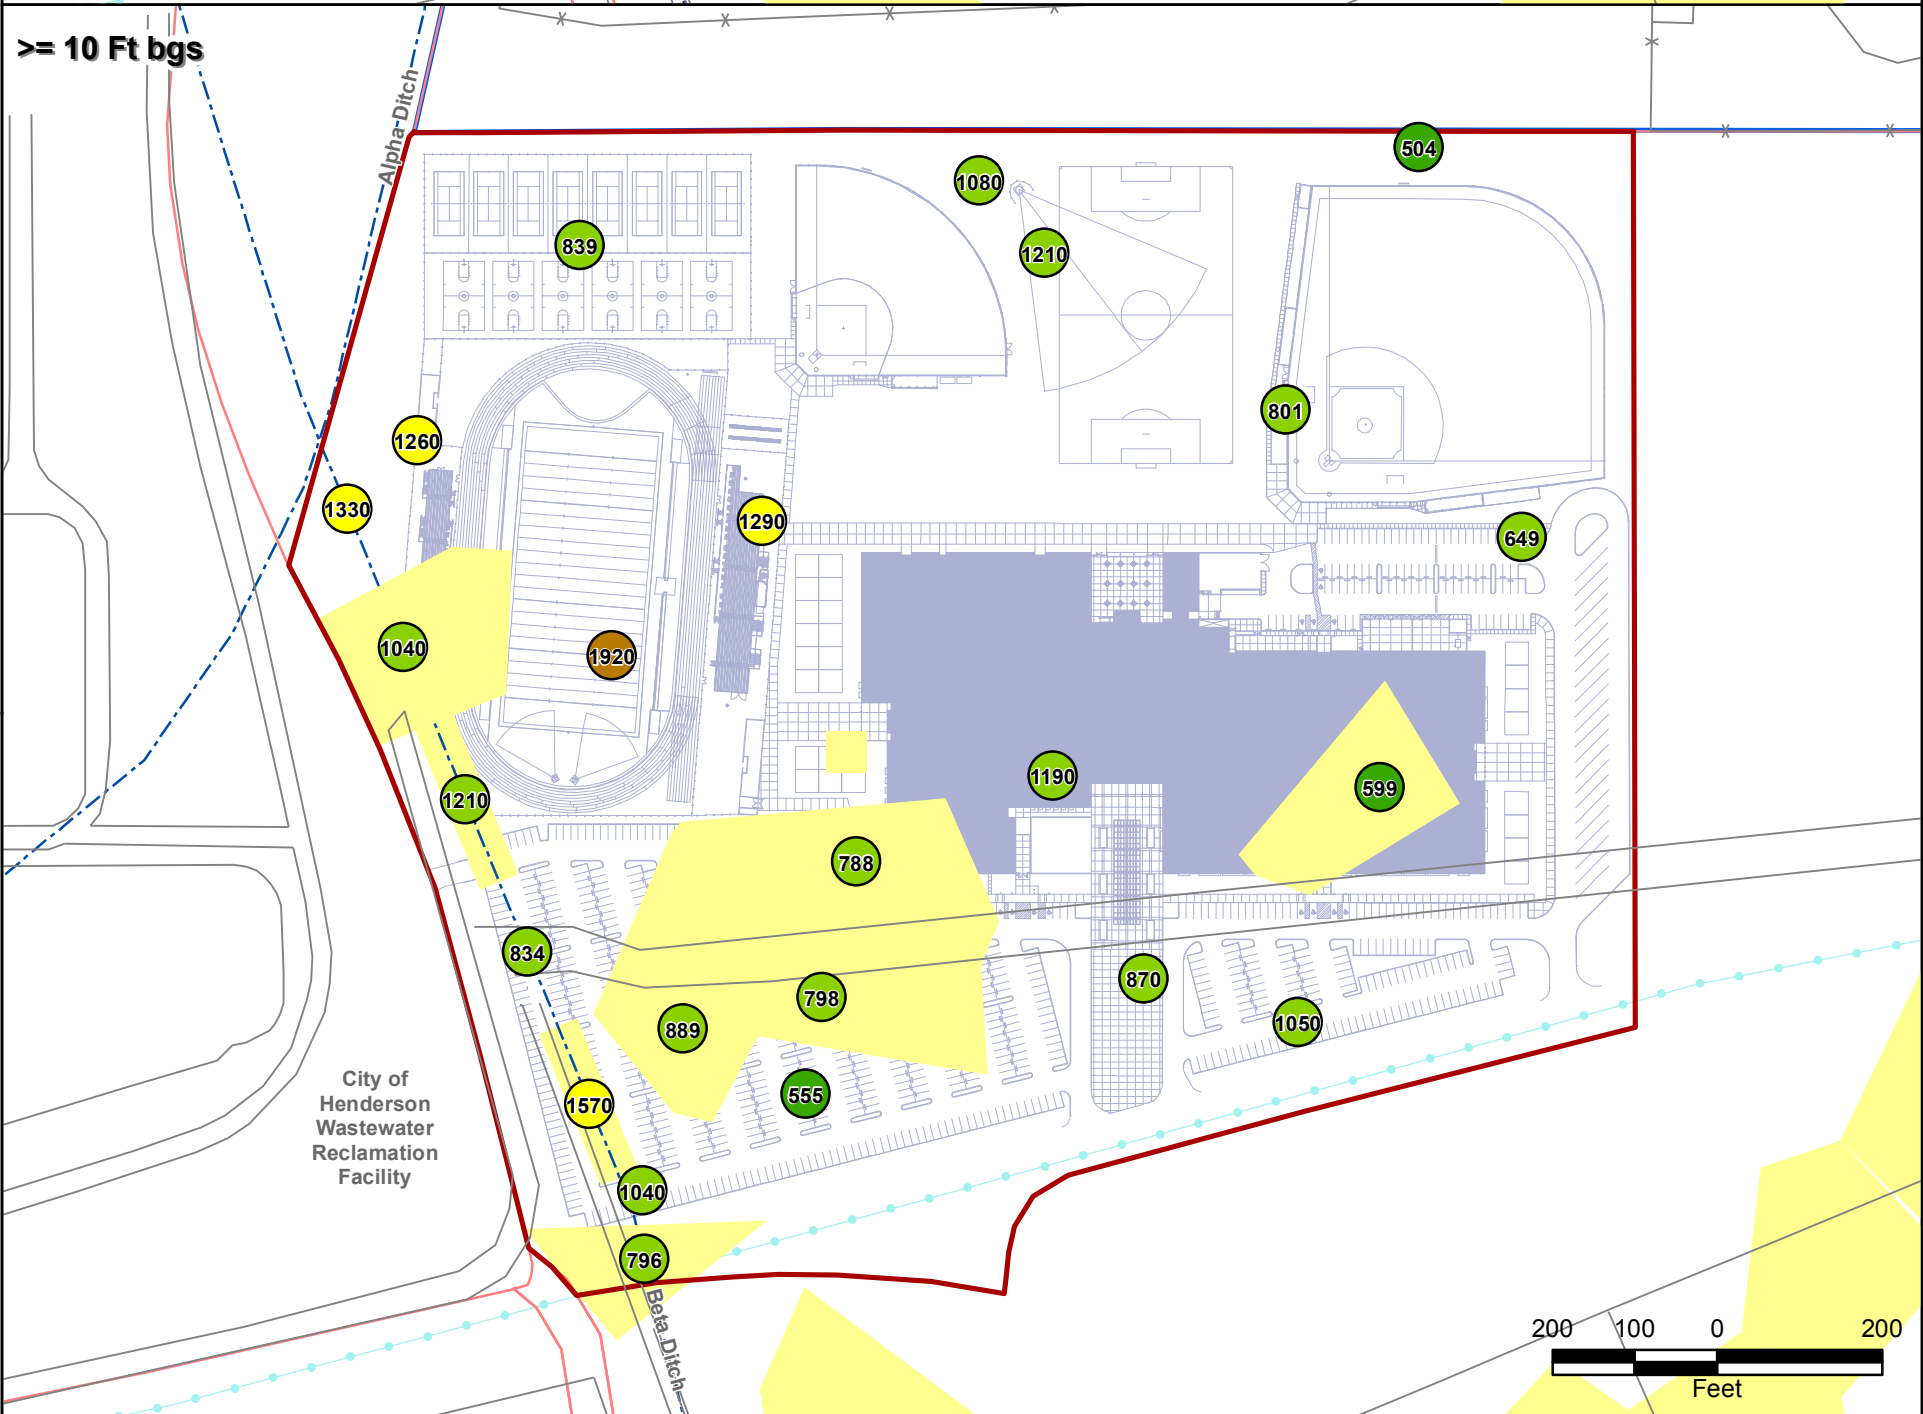
Galleria North-School Site Sub-Area	< -0.50 Std. Dev.	1.5 - 2.5 Std. Dev.
Site AOC3 Boundary	-0.50 - 0.50 Std. Dev.	> 2.5 Std. Dev.
Eastside Soil Sub-Areas	0.50 - 1.5 Std. Dev.	
Recent Soil Removal Areas

Note: Results shown are those used in the human health risk assessment. Standard deviations are calculated by ArcGIS using the statistical value field from the database (includes both detect and non-detect results).
