## DAILY PRODUCTION & QUALITY CONTROL REPORT

Project No./Contract No.	Project Title / Location	Day of Report	Report No.
6389	<b>BRC Eastside Common Areas Soils Remediation</b>	02-Sep-08	<b>65</b>

#### DAILY PHOTO LOG

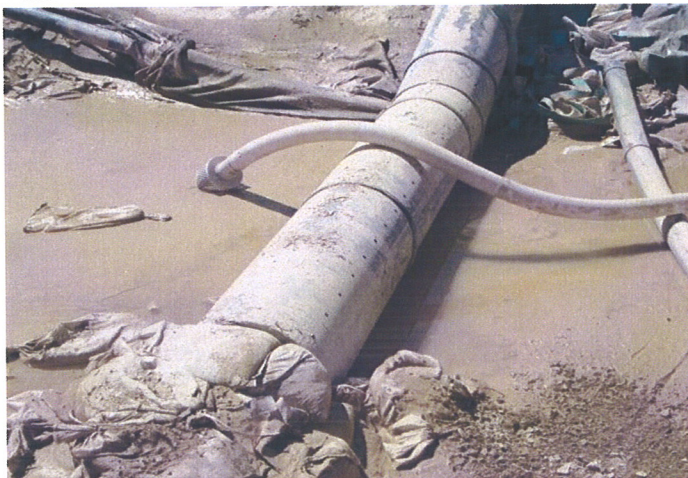
Photo 1

CAMU, Phase 1, Silt in sump to be removed.

- Northwest Detention Basin excavation - 631/637 scrapers - (800) cy - 1 scraper.
- Western Ditch. Power screener screening operations layer. Two (AAG) workers assisting in screening operation.
- Entact maintained 12" clean soil cap over west haul rd and bypass rd.
- Dewatered last 18' of water. Silt approx. 6" - 8" at bottom of sump. Drying out will shovel out 9/2/08.
- Continued shoveling and brooming runoff silt from geocomposite..
- Covered Westside slope with Geotextile to meet spec.
- Continued fence installation in Tronox area for haul road construction.
- GES supplied a meter and Entact probed the vadose sump and verified that no water was present. Also probed with a pump.

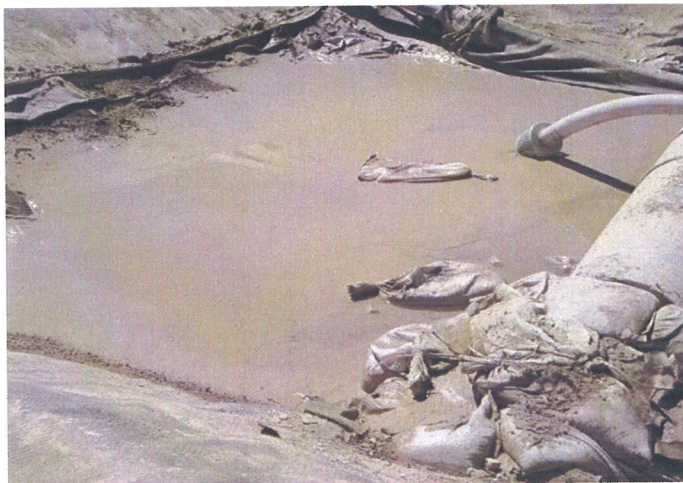
Photo 2

CAMU: Phase 1 sump to be cleaned.

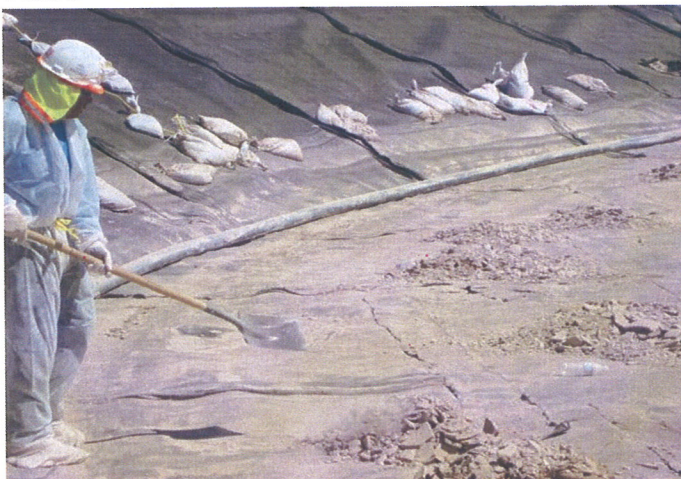
Photo 3

CAMU: Phase 1 Northeast floor being cleaned of silt..

Inspected shoveling/sweeping cleanup activitiy at west slope floor area. approved floor for ops placement closer to sump.

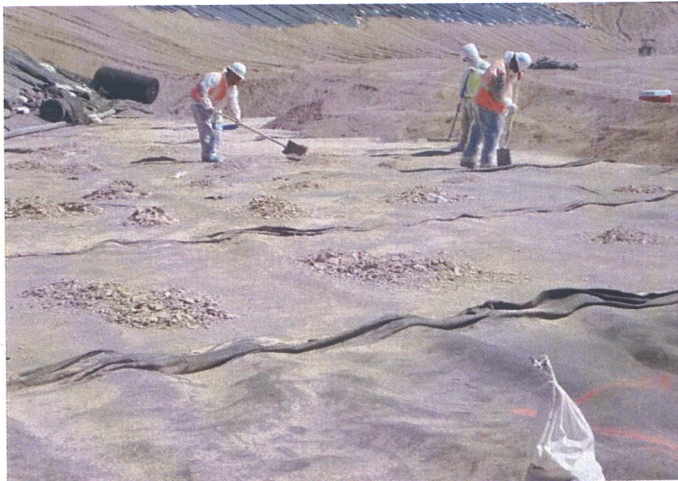
Photo 4

CAMU, Phase 1, Northeast floor being cleaned.
