# DAILY PRODUCTION & QUALITY CONTROL REPORT

| Project No. / Contract No. | Project Title / Location | Day of Report | Report No. |
|---|---|---|---|
| 6389 | BRC Eastside Common Areas Soils Remediation | 27-Feb-09 | 229 |

## DAILY PHOTO LOG

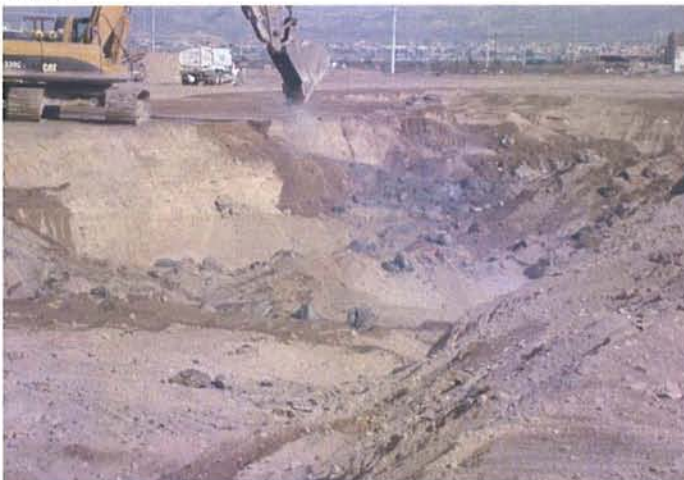
Photo 1

**Inspections:** Silt trenches, NW-2, Waste continues to be trash and paper products with soils. Also pyrophoric substances.

CAMU: Slit Trench, NW-2.

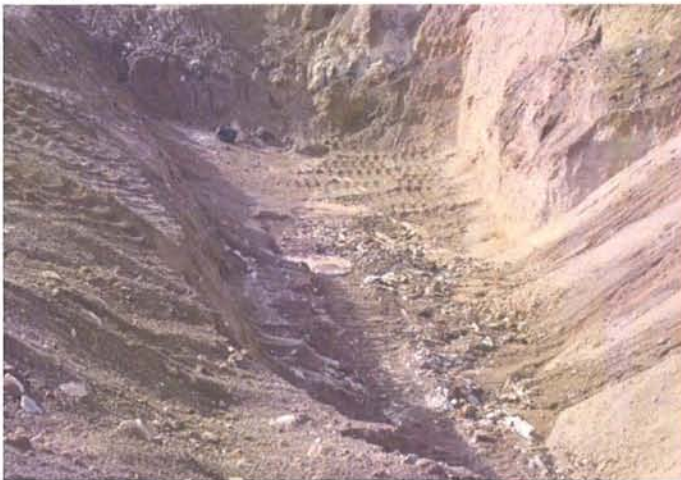
Photo 2

NW-3, Waste continued to be debris and with small amounts of paper. A green lime color waste continues. Pyrophoric substances activated periodically.

Camu: Slit trench, NW-3.

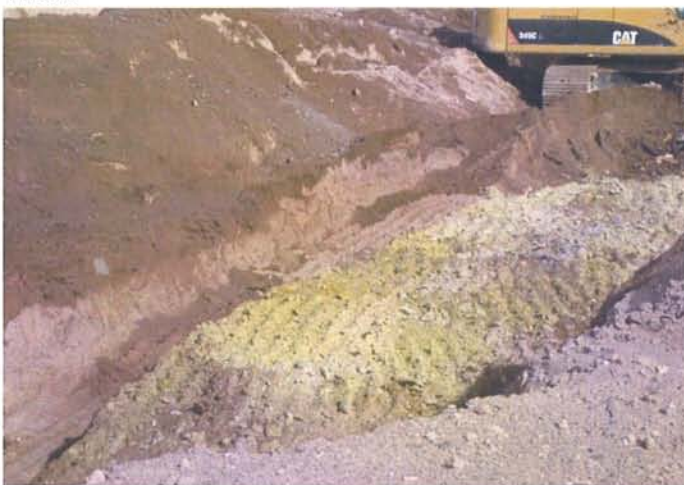
Photo 3

CAMU: Slit trench, NW-3.
