## DAILY PRODUCTION & QUALITY CONTROL REPORT

| Project No. / Contract No. | Project Title / Location | Day of Report | Report No. |
|---|---|---|---|
| 6389 | BRC Eastside Common Areas Soils Remediation | 26-Mar-09 | 256 |

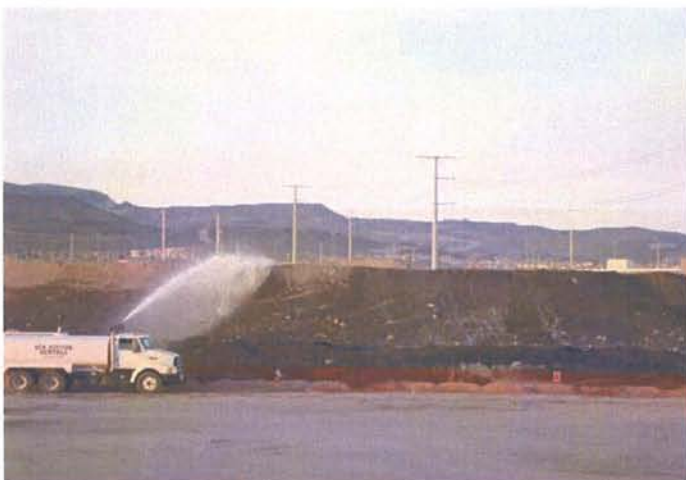
Photo 1

CAMU: Phase I, North Slope, Chemloc application.

- All intrusive excavation work shut down due to high winds.
- Water trucks applied Chemloc surfactant on Phase I North slope and all disturbed areas on site.
- Continued hauling and placing 6" minus soils to Silt North.
- Phase I LCRS measured and pumped. Phase I Vadose measured. Phase II LCRS measured and pumped.

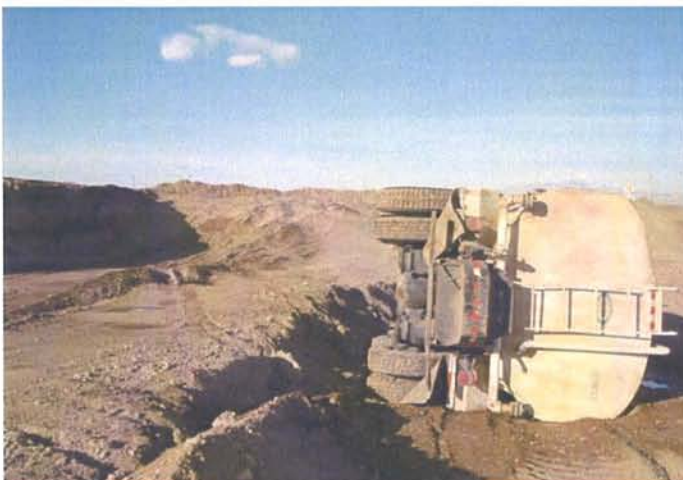
Photo 2

Eastside: Water truck incident.

Eastside: Weston responded to water truck incident and monitored recovery of the truck.  
Weston found a break in the fence on eastside. Temporary repair made. Notified repair contractor, MGA and BRC.

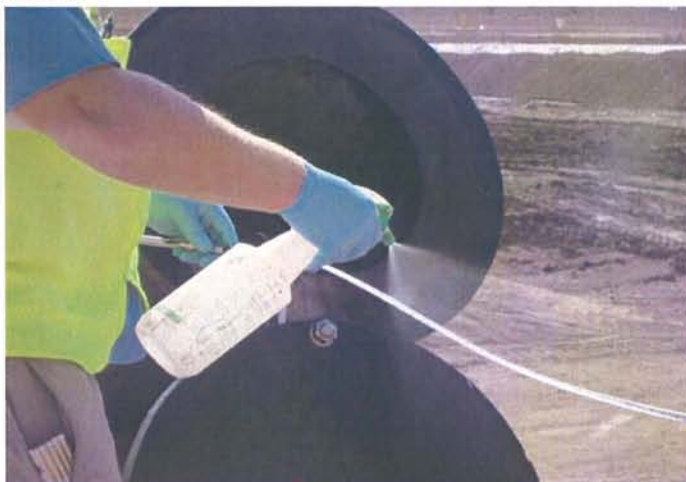
Photo 3

CAMU: Sump and Vadose monitoring.

**Sump/Vadose Monitoring:** Phase I: LCRS Sump: Measurement taken: 8AM, (2.80) 6PM, (0.90). Water Pumped: 1,000 gallons.  
Vadose: Measurement taken: (1.50). No pumping.  
Phase II: LCRS Sump: Measurement taken: 8AM, (2.90), 6PM, (2.30), 8:30PM, (2.00). Water Pumped: 3,100 gallon.  
Vadose: Dry.

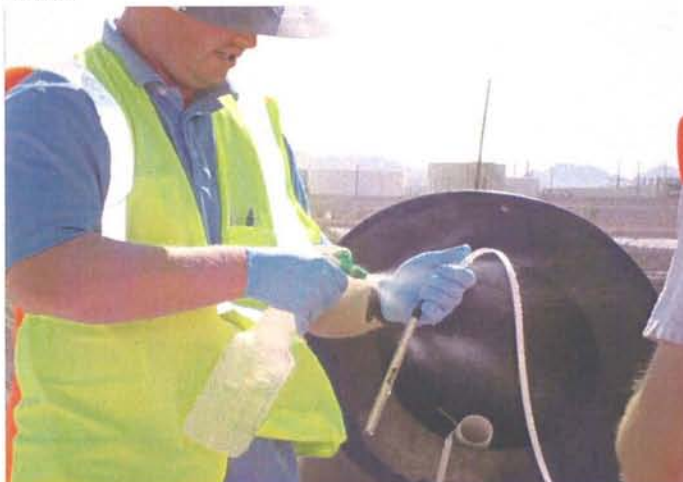
Photo 4

CAMU: Sump and Vadose monitoring.
