## DAILY PRODUCTION & QUALITY CONTROL REPORT

| Project No. / Contract No. | Project Title / Location | City of Report | Report No. |
|---|---|---|---|
| 6399 | BRC Eastside Common Areas Soils Remediation | 06-Apr-09 | 267 |

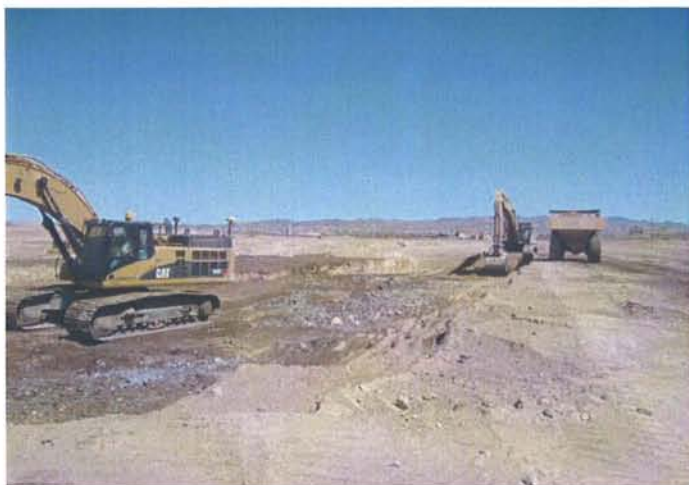
Photo 1

CAMU: Slit Trench, SW-1.

| DAILY PRODUCTION & QUALITY CONTROL REPORT | | | | |
|---|---|---|---|---|
| - SW-1, Silt trench, (2) excavators began removing overburden and waste, hauled to Phase II. | | | | |

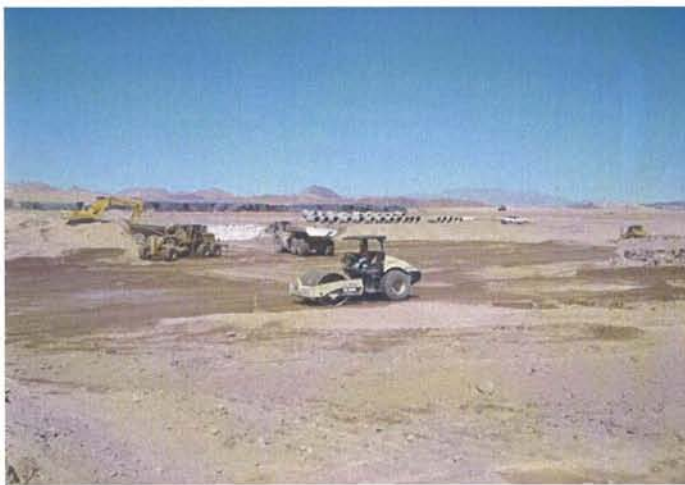
Photo 2

CAMU: Slit trenches backfill.

| DAILY PRODUCTION & QUALITY CONTROL REPORT | | | | |
|---|---|---|---|---|
| - Backfilling and compacting trenches at the west end NW-1, NW-2, NW-3. Also leveling between trenches. | | | | |

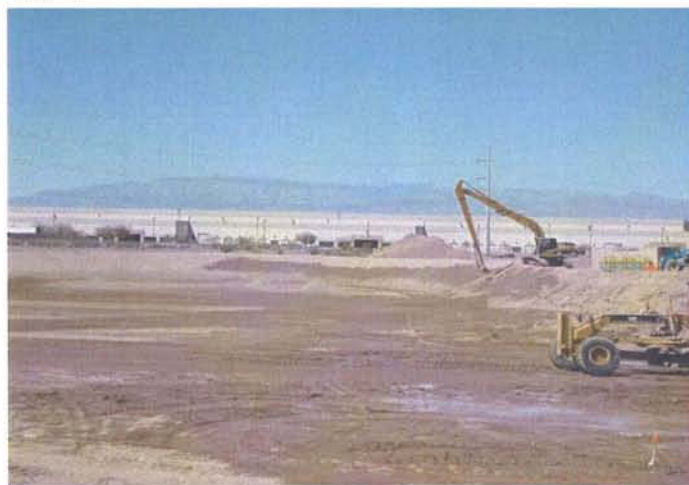
Photo 3

CAMU: Phase 3B.

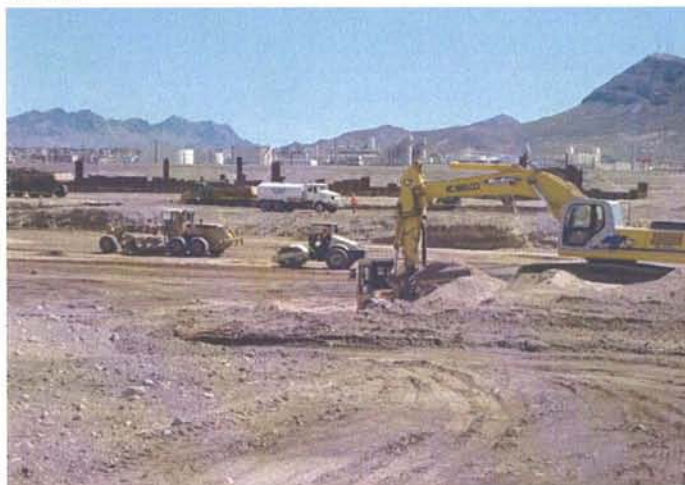
Photo 4

CAMU: Phase 3B, North slope excavation.

| DAILY PRODUCTION & QUALITY CONTROL REPORT | | | | |
|---|---|---|---|---|
| - Phase 3B, grading floor, (2) excavators, removing soils from north slope area. Loading/hauling into above silt trenches for backfill material. | | | | |
