Project No./Contract No.	Project Title / Location	Day of Report	Report No.
6389	BRC Eastside Common Areas Soils Remediation	06-Jul-09	356

DAILY PRODUCTION & QUALITY CONTROL REPORT

DAILY PHOTO LOG

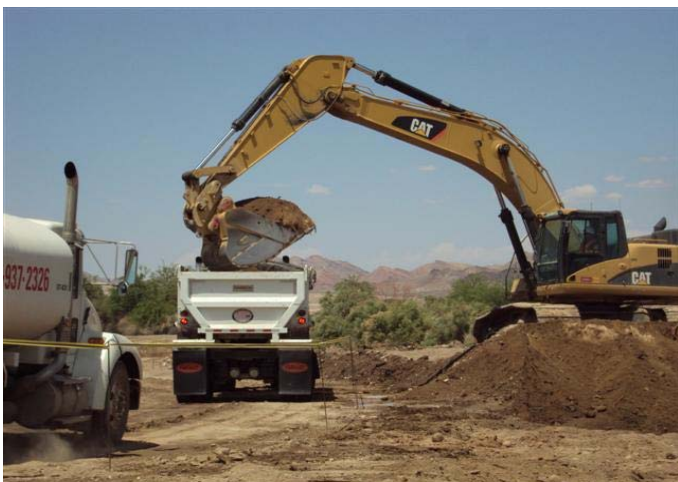
Photo 1

Eastside: Western Hook.

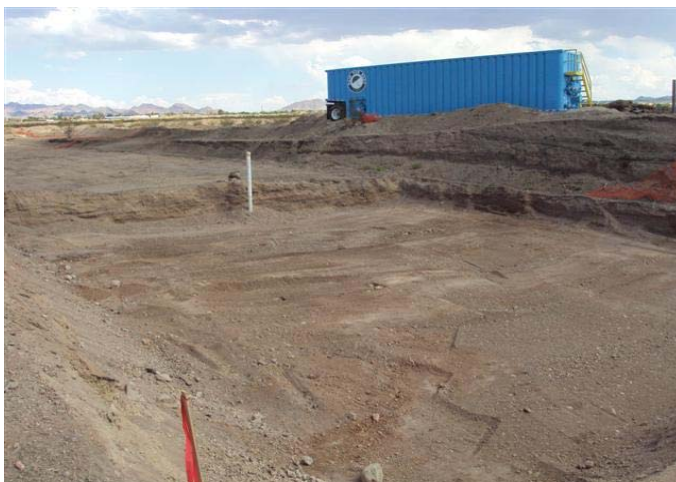
Photo 2

Eastside: 50' X 50' soil removal in sewer alignment corridor.

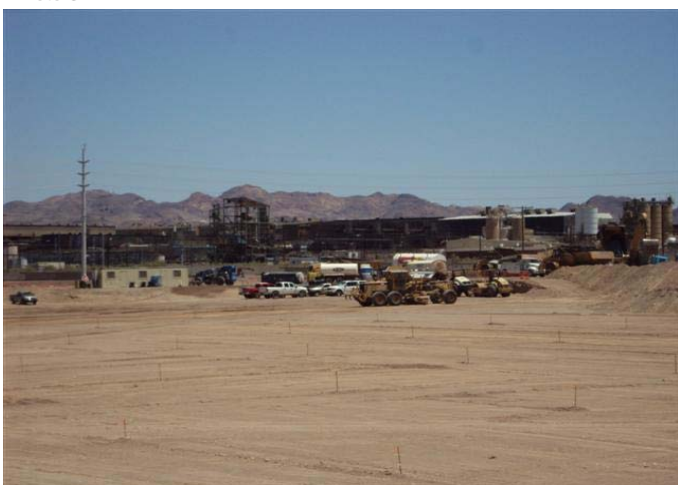
Photo 3

CAMU: Phase V Cell Floor.

- Phase IV, ESI continued to install geosynthetics.
- Phase V, continued grading cell floor.
- Entact checked the water level in Phase I LCRS sump and the vadose zone. Also Phase II LCRS sump.

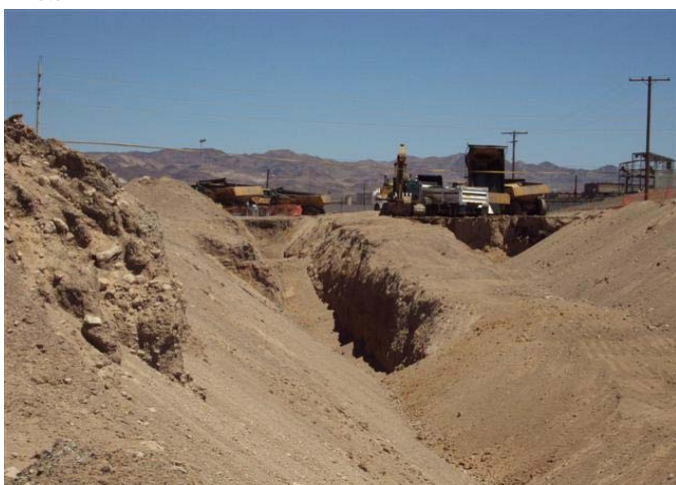
Photo 4

CAMU: SE-2, Slit trench.

- SW-12, pH: 6.
- Night Shift:
- Hauled material from Beta ditch stockpile and the North Beta Ditch 1" minus stockpile.
CAMU Activity:
- Day Shift:
- SE-2, Silt trench, continue excavation east, beyond design limits loading out trash and debris, hauling to Phase II for placement.
