October 15, 2009  
Project No. 20092598V1

**RE: Galleria North and Sunset North Additional Sampling, Henderson, Nevada**

Vicinity Map  
Galleria North & Sunset North  
Sub-Area

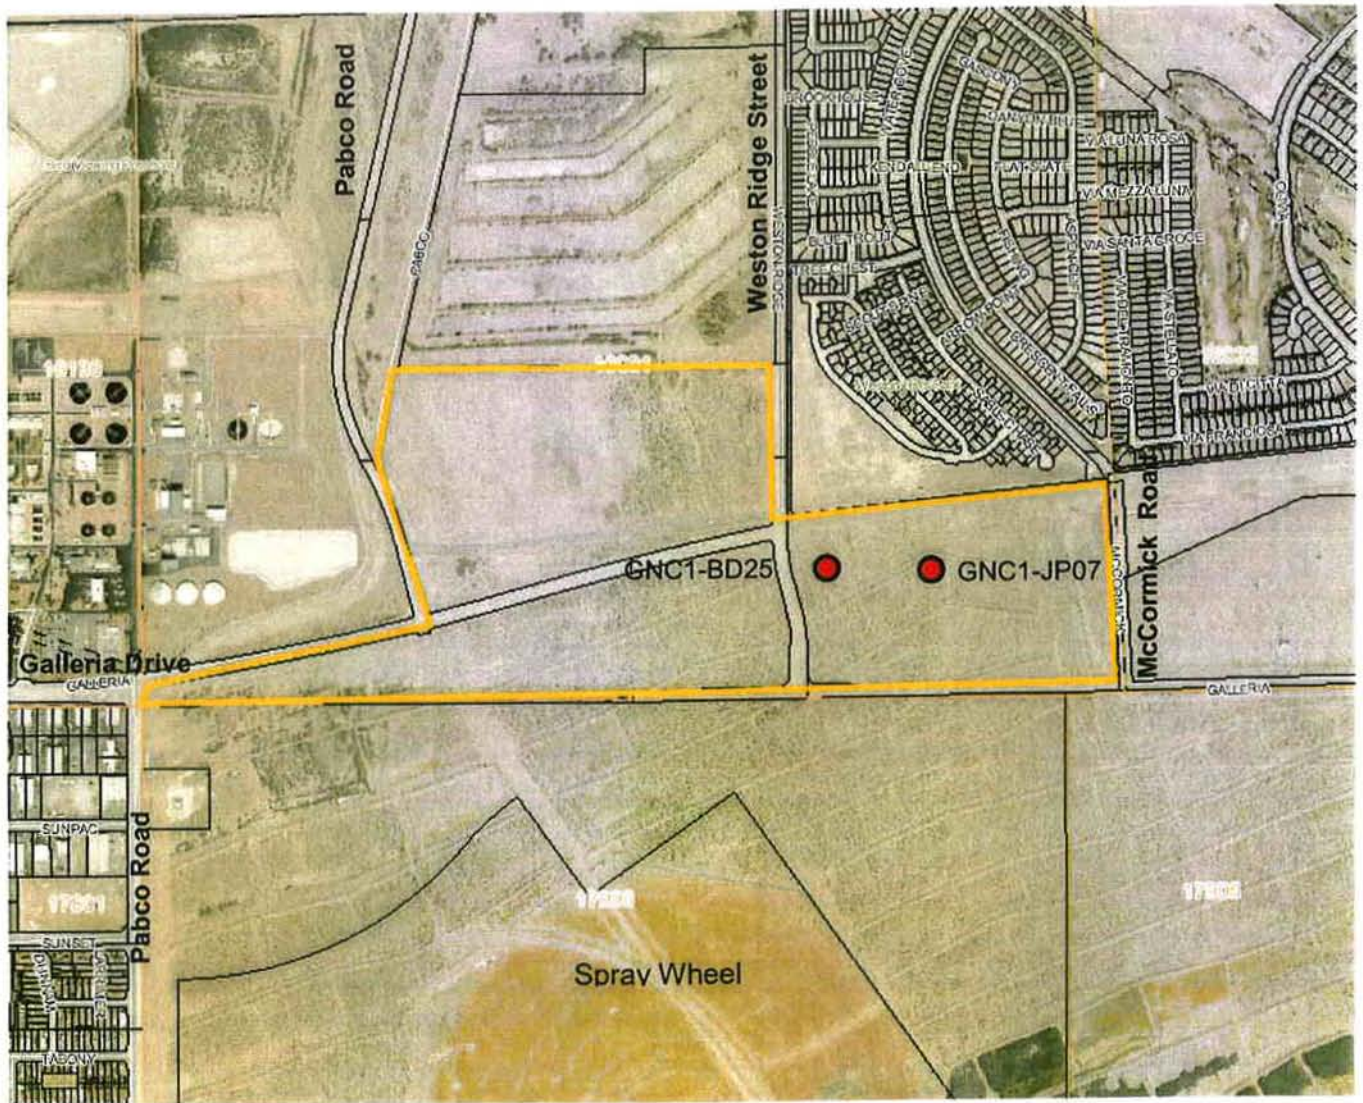
Figure 3

Exploration Location

Site Boundary

Exploration Location Map  
Galleria North Sub-Area  
Las Vegas, Nevada

Documentation of the field activities consists of figures showing the site location (Vicinity Map, Figure 1), boring locations (Site Map, Figure 2 and Figure 3), photographs of representative boring locations (Figure 4) and boring logs for the central boring of each group (Figure 5 through 7). Only one boring log was prepared for each group of borings due to the close proximity of the locations (within 10-feet of the central boring). These documents are included as attachments. Copies of the Chain-of-Custodies and daily safety meeting forms are also included as attachments.

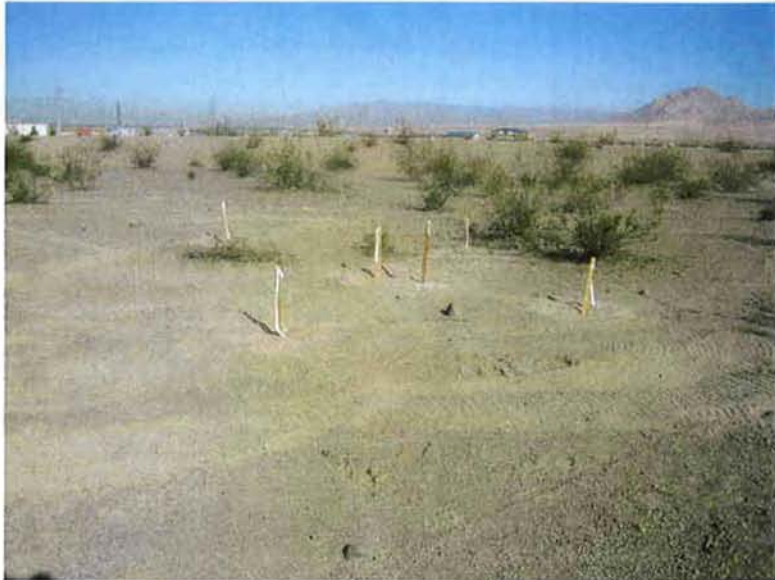
1. Sunset North: View showing JP04 group of borings.

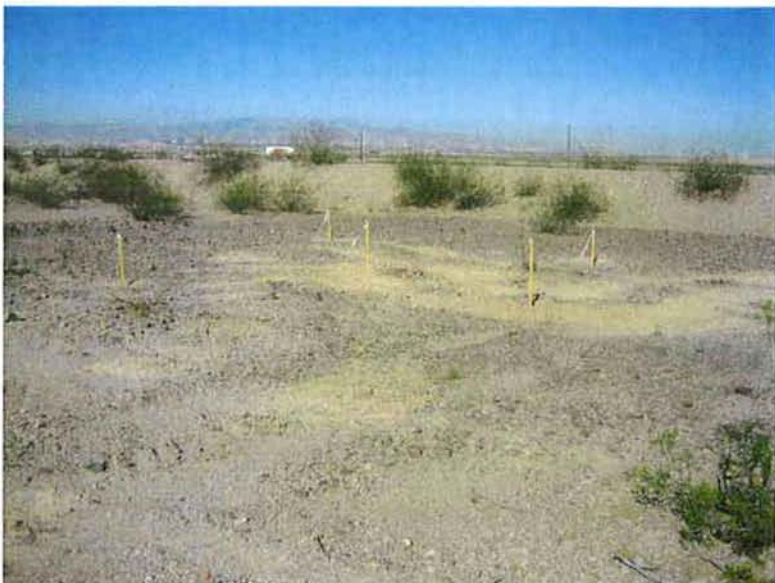
2. Galleria North: View showing JP07 boring group.

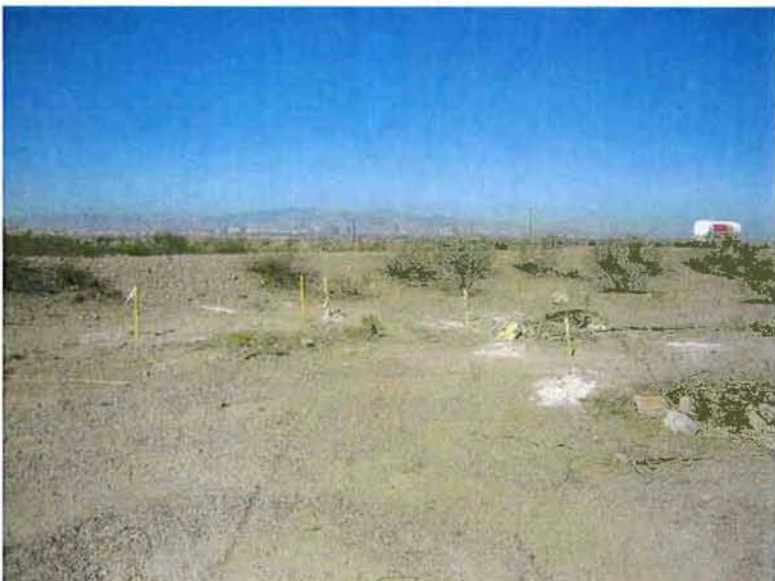
3. Galleria North: View showing BD25 borings group.

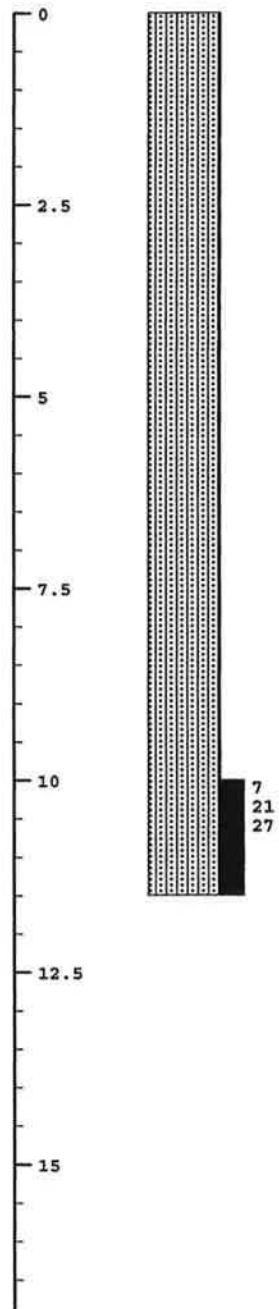
# EXPLORATION LOG SNC1-JP04C

**PROJECT:** GALLERIA & SUNSET NORTH SAMPLING  
**EXPLORATION LOCATION:** HENDERSON, NEVADA  
**EXPLORATION SIZE (dia.):** 6 1/4" O.D. H.S. AUGERS  
**ELEVATION:** EXISTING GROUND SURFACE

**PROJECT NO.:** 20092598V1  
**EXPLORATION DATE:** 9/29/09  
**EQUIPMENT:** DIEDRICH D-50 TRACK RIG  
**LOGGED BY:** SANCHEZ/DAVIS

SM	Light brown (7.5YR 6/3)silty SAND, trace gravel, dry and medium dense.						
2.5									
5									
7.5									
10			...PIDs: 10.6 eV = 0.0 ppmV; 11.7 eV = 0.0 ppmV.						
12.5			END OF BORING AT 11.5 FEET						
15

Soil samples were logged according to the USCS Classification by a qualified Geologist. Boring logs were prepared for the locations drilled (Appendix A, Figures 5 through 7). The soil from each sample interval was also field screened for volatile organic vapors (VOCs) using 10.6 eV and 11.7 eV photoionization detector probes (PIDs). The PID results and any odors or soil staining observed during the course of fieldwork are shown on the boring logs.

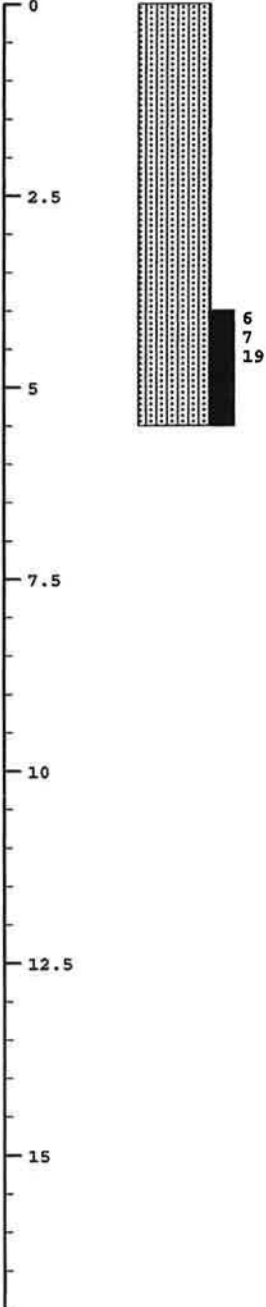
# EXPLORATION LOG GNC1-JP07C

**PROJECT:** GALLERIA & SUNSET NORTH SAMPLING  
**EXPLORATION LOCATION:** HENDERSON, NEVADA  
**EXPLORATION SIZE (dia.):** 6 1/4" O.D. H.S. AUGERS  
**ELEVATION:** EXISTING GROUND SURFACE

**PROJECT NO.:** 20092598V1  
**EXPLORATION DATE:** 9/29/09  
**EQUIPMENT:** DIEDRICH D-50 TRACK RIG  
**LOGGED BY:** SANCHEZ/DAVIS

SM	Light brown (7.5YR 6/3)silty SAND with gravel, dry and medium dense.						
2.5			...six-inch thick gravel layer.						
5			...PIDs: 10.6 eV = 0.0 ppmV; 11.7 eV = 0.0 ppmV.						
			END OF BORING AT 5.5 FEET						
7.5									
10									
12.5									
15
