DAILY PRODUCTION & QUALITY CONTROL REPORT

Project No./Contract No.	Project Title / Location	Day of Report	Report No.
6389	BRC Eastside Common Areas Soils Remediation	04-Aug-08	39

DAILY PHOTO LOG

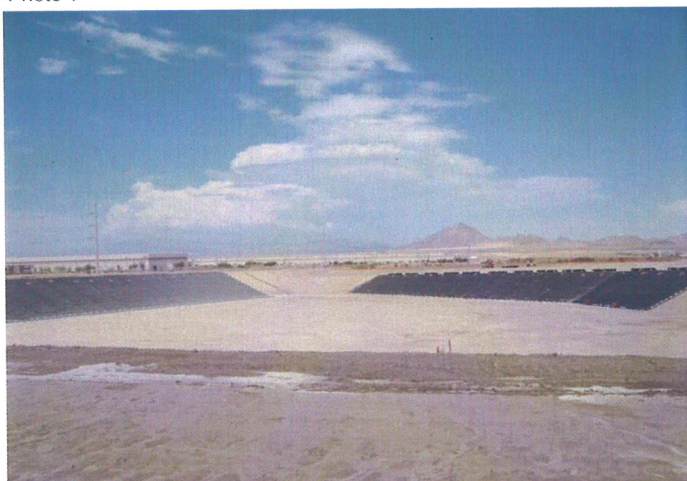
Photo 1

CAMU, Phase 1, East slope liner installed.

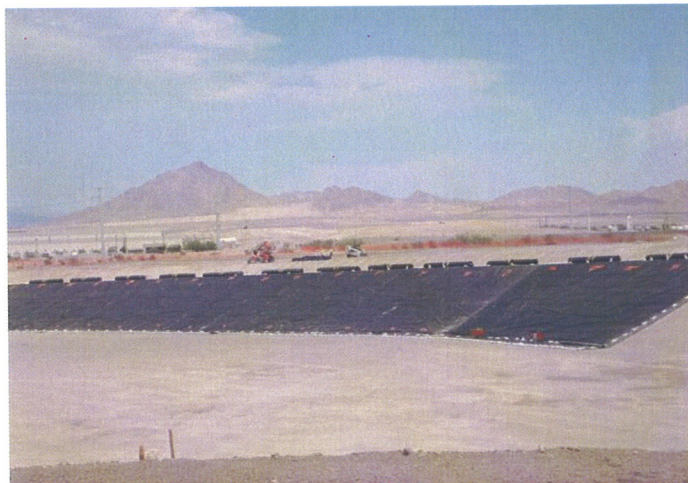
Photo 2

Liner Crew installed liner on east slope, & shelf portion.

CAMU, Phase 1, Liner Crew Deploying liner on East Slope.

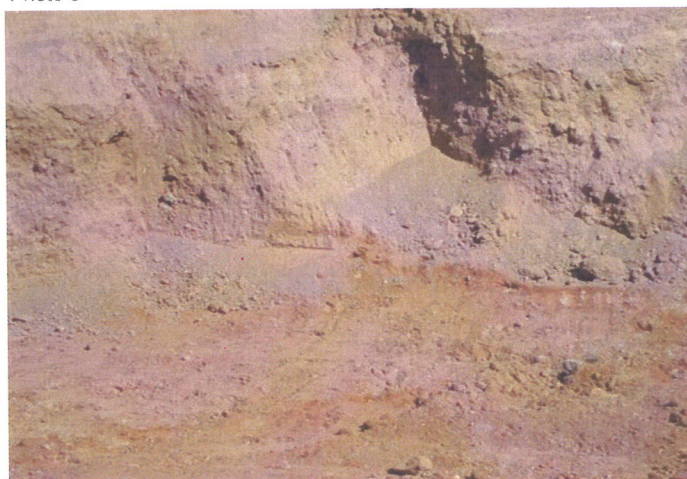
Photo 3

- SW-8, 345 excavator remediating additional discolored soils below liner. Monitored by Construction Manager. (97) loads = (2,134) cy, to beta - ditch stockpile. Two spots excavated an additional 10' total, still discolored.

Eastside, SW-8, Remediation below liner. Two areas remain discolored after 10' excavation below liner.

Eastside, SW-8. Additional discolored soils excavated to 5' below liner.

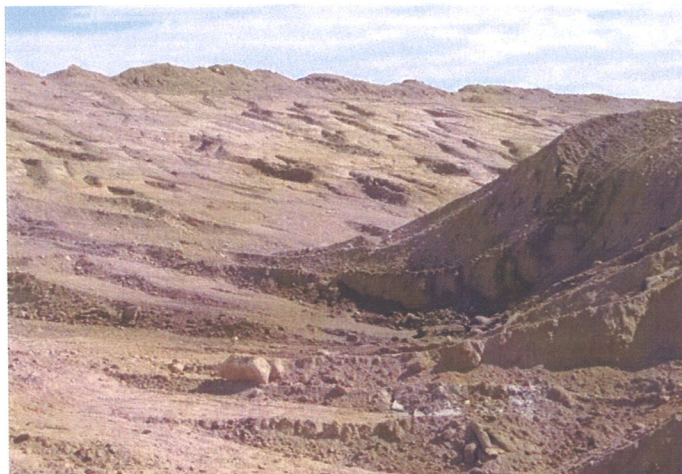
Photo 4

Eastside, SW-8 discolored soils.
