DAILY PRODUCTION & QUALITY CONTROL REPORT

Project No./Contract No.	Project Title / Location	Day of Report	Report No.
6389	BRC Eastside Common Areas Soils Remediation	14-May-09	305

DAILY PHOTO LOG

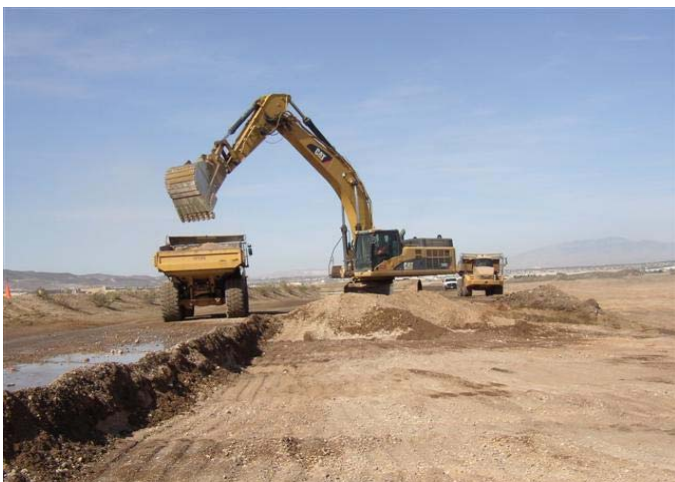
Photo 1

Eastside: PUB-5 haul rd.

- Continued scraping and loading material on haul road next to PUB-5. Hauling to Beta ditch staging area.
- Continue final scrape of haul rd. PUA-8 and PUA-9. Hauling to Beta ditch staging area.
- Tracking wet material from SW-7, spread out in dry ponds.
- Scrape and stockpile Southern Rib.
- Began clearing and grubbing tamarisk and brush at Western Hook in ditch area.
- Continued North Beta ditch excavation, loading out and hauling to beta ditch staging area.
- Sampled SW-12, pH: 6.

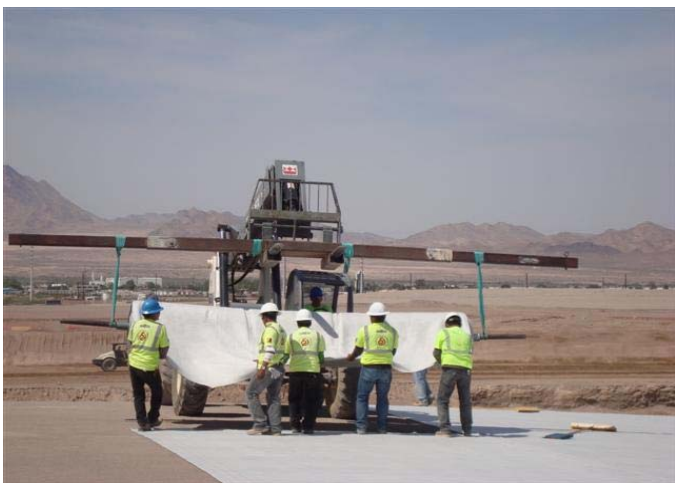
Photo 3

CAMU: BMI South Landfill.

Monitored the installation of geosynthetics at the BMI South Landfill.

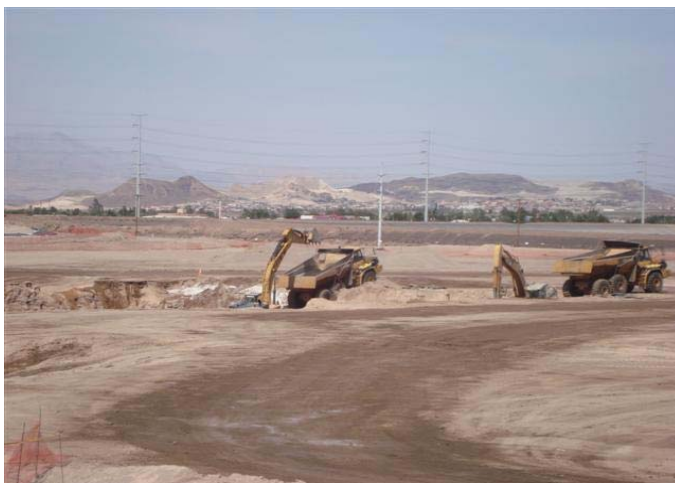
Photo 4

MGA and Weston inspected silt trenches NE-1 and NE-2. West portion waste removed to visibly clean soil. Not to design grade. Entact pot holed to design grade depth in (3) spots to design depth all floors and walls were visibly clean gravel. Area approved for backfill. Appeared to be an access ramp as waste was evident as they excavated to the east. Entact had a articulating haul truck roll its bed over during the day shift. No injuries, truck was inspected and righted then driven out of Phase II.

CAMU: Slit trenches NE-1 and NE-2.

Inspections: CAMU: Weston monitored sump access. N/A.
MGA and Weston inspected West end portion of NE-1 and NE-2, Slit trenches. Approved just beyond Phase IV limits.
