DAILY PRODUCTION & QUALITY CONTROL REPORT

Project No./Contract No.	Project Title / Location	Day of Report	Report No.
6389	BRC Eastside Common Areas Soils Remediation	29-Jul-08	34

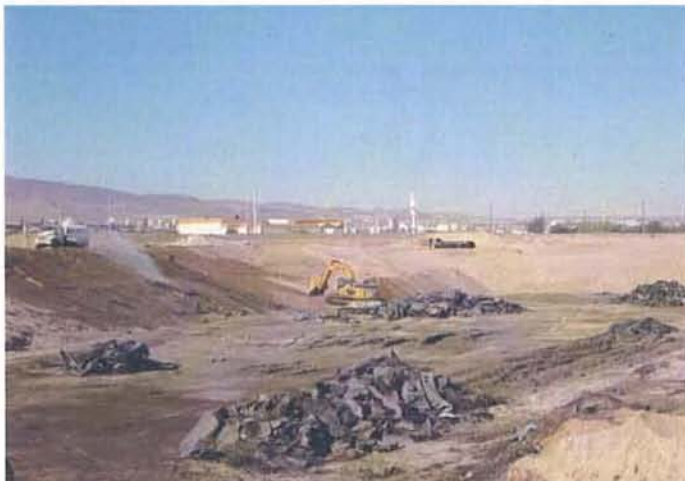
Photo 1

Eastside: SW-8, overexcavated to total of 18" below liner. Per RFI-019. Entact notified Construction Manager there are some areas/spots that still have discoloration. Construction manager, inspected and took pictures. After further evaluation with team, it has been determined to remove discolored soils an additional 4" maximum only when needed. This will be monitored and pictures taken during excavation.

Eastside, SW-8, cleaning residual discolored soils, per RFI-019.

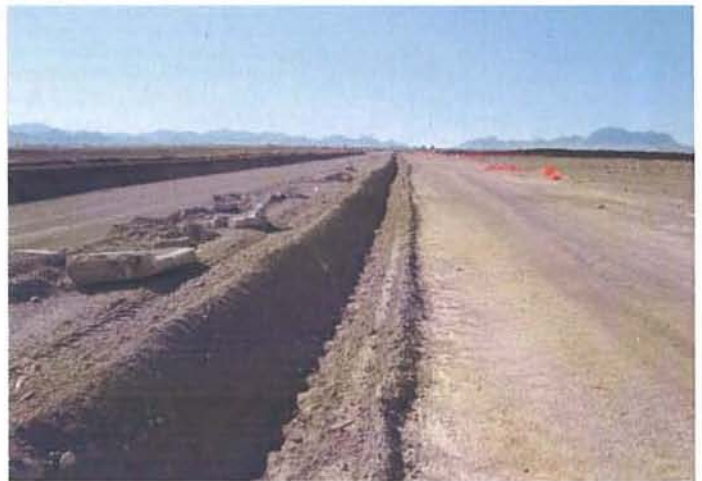
Photo 2

Other: Sewer Realignment: Berm work ongoing. Construction fence being installed.

Eastside, Sewer Realignment, berm/ditch installation.

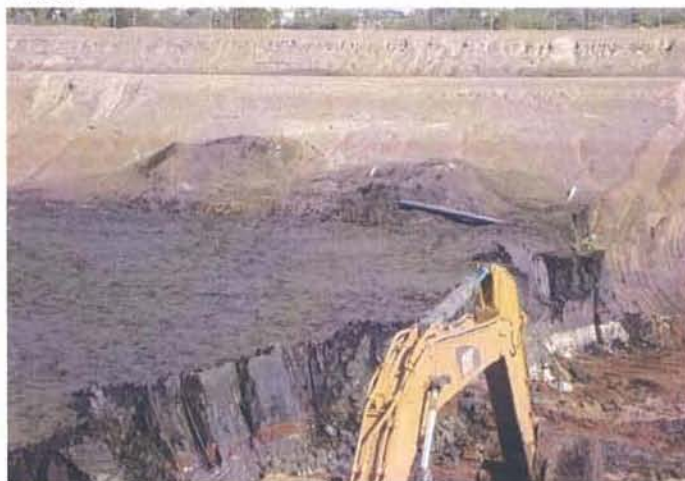
Photo 3

- Loading out dried material from SW-4 using 345 excavator. (4) haul trucks hauling to beta ditch stockpile. 182 loads, (3,640) cy.
- Leveled material from SW-4 on staging area and beta ditch using D6 dozer..
- D8 Dozer diking wet pond material that is spread over the dry ponds.
- Versatile tractor and pans transporting dried out material from CTR-2 and spreading at stockpile. 77 loads, (2,310) cy.
- SW-8, 345 excavator cleaning discolored soils from slopes. Remediating per RFI - 019.
- Estimated dried material hauled to stockpiles: 259 loads, (5,950) cy daily, (TBD)cy cumulative.
- Welded 3" pipe for future pumping operations.

Eastside, SW-4, Loadout operation.

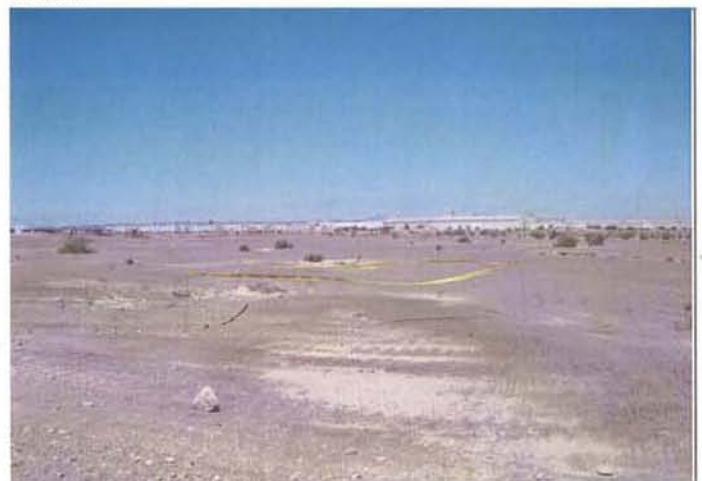
Photo 4

CAMU: Barracaded with caution tape area where Burrowing Owls are residing.

CAMU, Caution tape around burrowing Owls. Non work area.
